**Subject: Structural Review of the Hal Moe Pool Site**

# Hal Moe Pool Building

## Structural Assessment

405 Third St.  
Snohomish, WA 98290

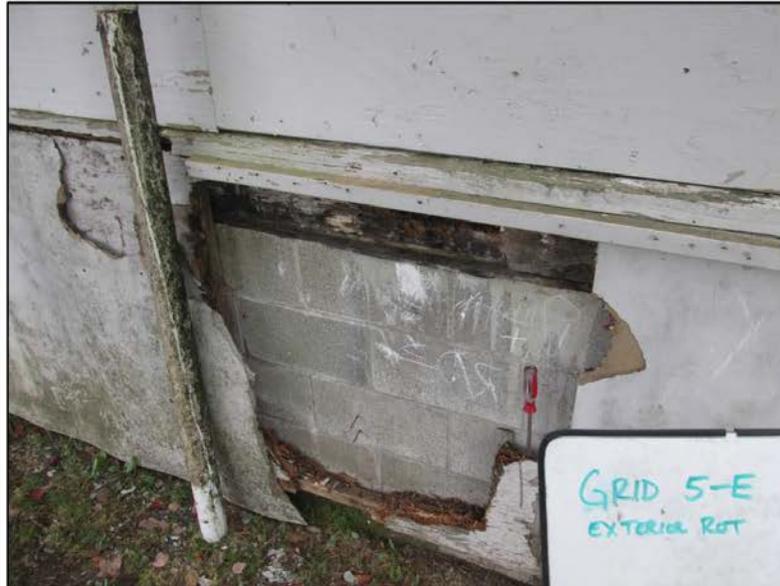
The exterior walls consisted of sheathed wood studs on top of masonry stem walls. Refer to photo 9. The masonry wall ran around the perimeter of the main pool structure. The exterior of the masonry was furred out with wood panel siding. Where side rooms were located off the main structure, the exterior walls consist only of wood studs and plywood sheathing. At several locations it was observed that the exterior siding was severely rotted. Refer to photos 10 and 11. While this condition was common around the perimeter, it seemed especially prevalent at locations where the roof gutter pipes were missing.

Photo 9: Lower CMU Wall with Stud Wall Above

The exterior of the building was constructed from a combination of wood and masonry walls. In the observation of the exterior, several locations of water damage and rot were found. The entire exterior wall system will need to be demolished and reconstructed. Typically, the exterior walls also support roof load and reconstruction of the exterior walls would require temporary shoring of the roof structure, causing additional labor during construction. In the case of this building, the roof structure is entirely supported by the glulam beams, alleviating the need for temporary shoring and allowing easier construction. Reframing the exterior walls would also allow for the opportunity to add doors and windows to the exterior. With the height of the roof framing, large roll up doors could be installed on either end of the building.

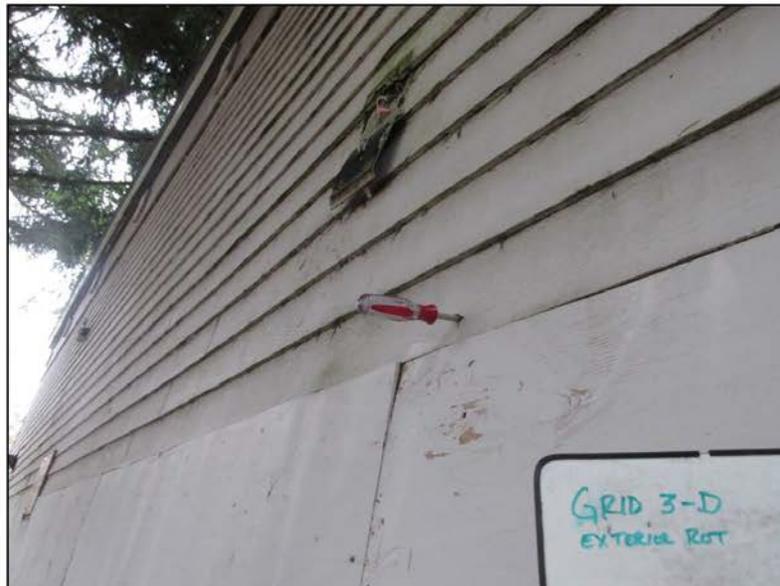
Photo 10: Exterior Siding Rot

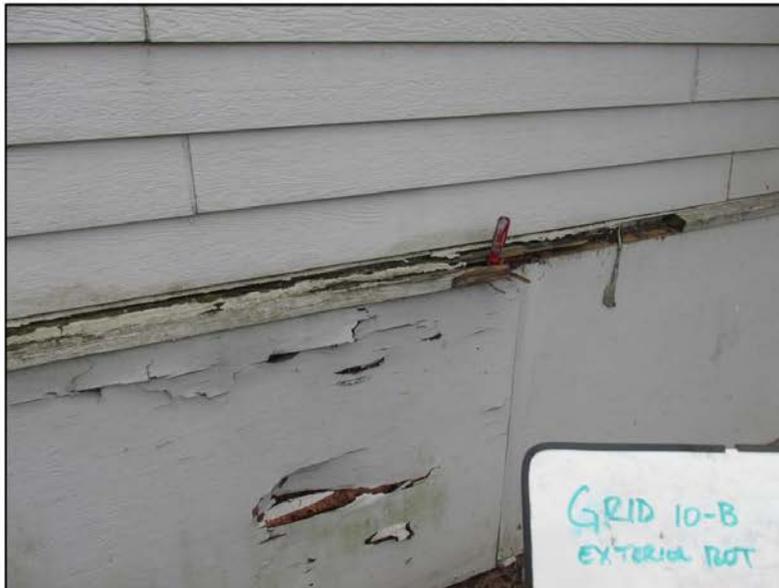
Photo 11: Exterior Siding Rot

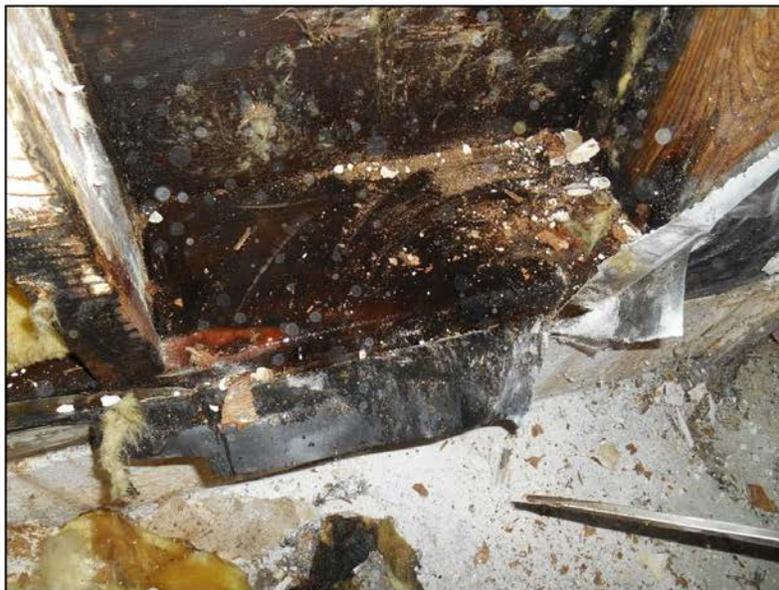
The wall cavities were opened during the assessment and observed. A vapor barrier was located on both the interior and exterior face of the studs. At the location opened, the wall cavity was damp and mold was observed. Rot was also present in the studs. Refer to photos 12 and 13. When a vapor barrier is applied to both the interior and exterior of a wall, it is common to have significant water damage without continual maintenance. The interior vapor barrier was likely required to protect the framing from the humid air caused by the pool. When the vapor barrier was punctured the water vapor in the air was allowed to enter the wall cavity, and then was not

able to escape causing the water to remain inside the wall cavity. It is likely that over the life of the building, small punctures occurred in the vapor barrier resulting in increased moisture inside the wall cavity.

Photo 12: Sill Plate Damp and Moldy

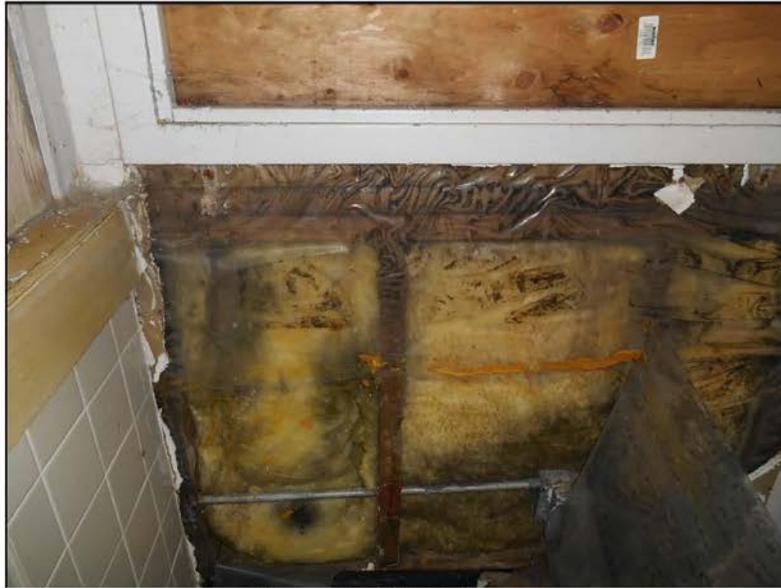
Photo 13: Mold in Stud Cavity

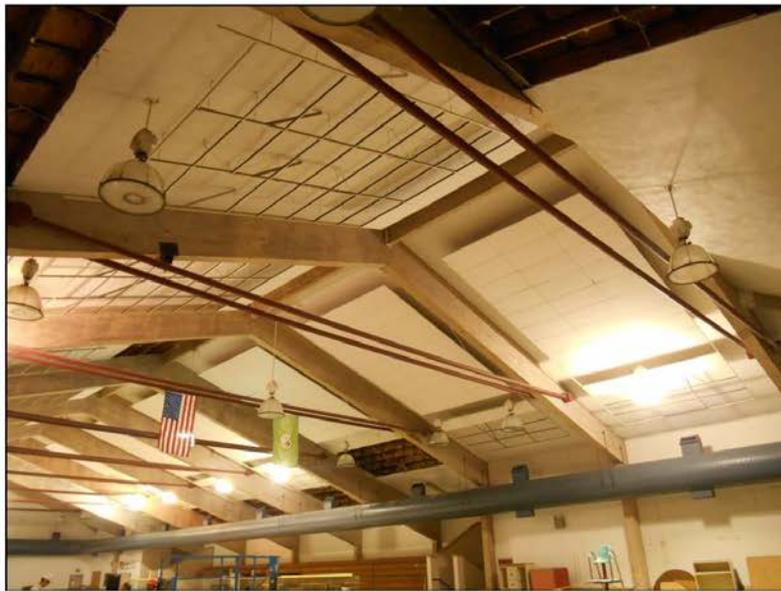
The roof structure consisted of roof sheathing nailed to flat 2x4 sleepers that were supported at intermediate, and end locations by roof rafters. The roof rafters spanned between glulam roof beams. The glulam beams were supported by glulam columns on the interior side of the exterior walls. Refer to photo 14.

Photo 14: Typical Pool Structure Framing

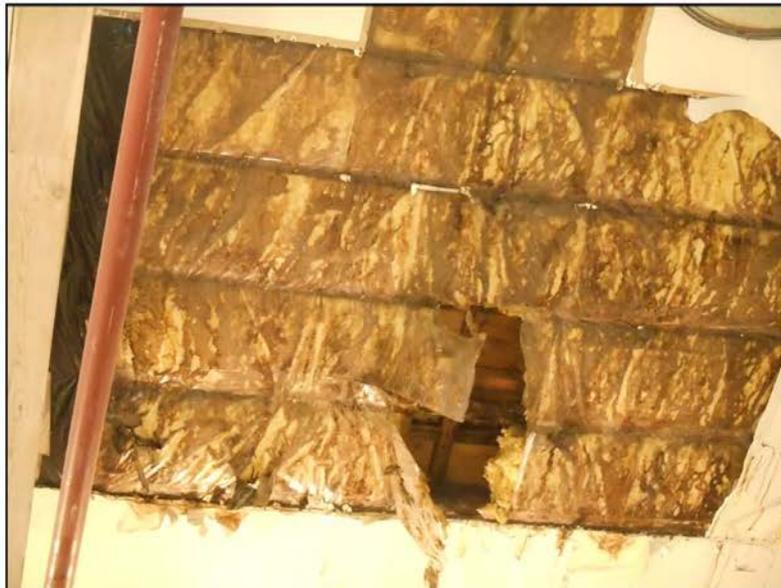
In many areas, the interior ceiling finish had fallen away exposing the roof framing and insulation. An interior and exterior vapor barrier was also installed on the roof. In many areas, the interior vapor barrier was exposed and the insulation was visible. In each of these locations mold was visible, and it appeared that water was trapped in the roof cavity. Refer to photo 15

Photo 15: Mold in Ceiling Cavity

The roof sheathing was damaged in several areas. Given the amount of damage, it is recommended that all of the roof sheathing and roofing be replaced. Almost all of the joists observed were affected by mold and some were also rotted. While the extent of the rot was minor, the amount of mold was extensive. Structurally, many of the joists are adequate, but it is recommended that any budget for remodeling include complete replacement of the joists. Given the cost of cleaning the mold and selective replacement, it will likely be more cost effective to replace all of the joists.

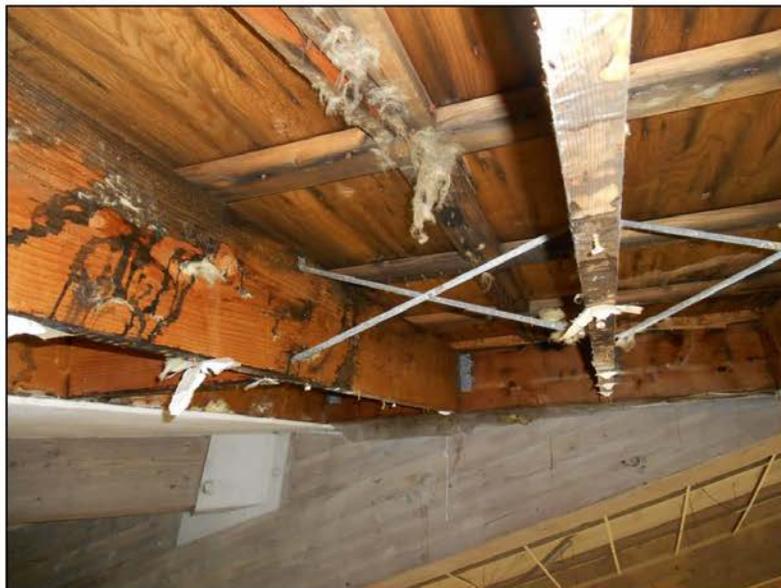
The roof joists were 2x12s spaced at 2'-0" on-center, and were observed from below where the interior ceiling finishes had fallen away. The locations observed showed signs of heavy water staining, mold, and minor rot. Refer to photo 16. The joists were supported at each end by a glulam beam, and were constructed with blocking between roof joists above the glulam beam.

Photo 16: Typical Roof Framing

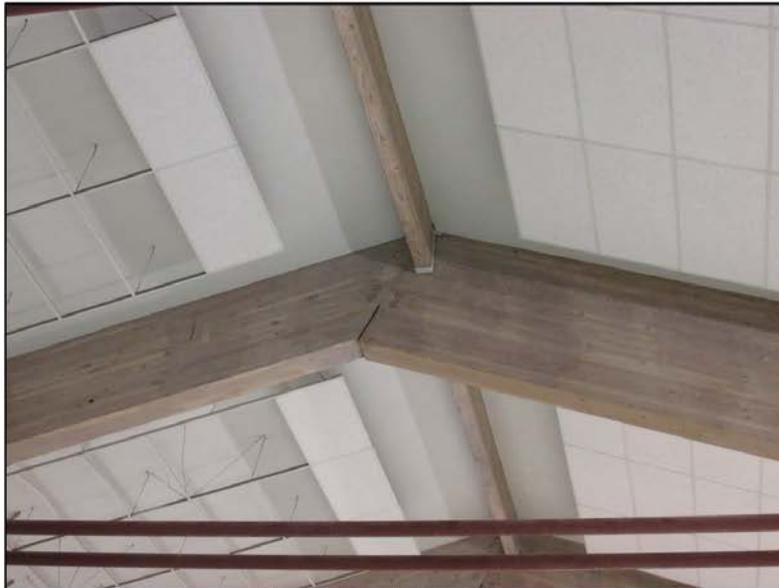
The glulam roof beams (10 3/4 x 36 north side spanning 35'-0", 10 3/4 x 48 south side spanning 47'-0") follow the slope of the roof, and were connected at the ridge by a bolted knife plate. There was also a steel collar tie connecting the glulam beams. At the time of the observation the glulam roof beams appeared to be in good condition, and there was no observable water damage or rot present. Refer to photos 17-21.

The glulam beams and columns all appeared to be in good condition with no observable structural damage. Most beams were water stained from years of service in a humid environment.

Photo 17: Typical Roof Beam

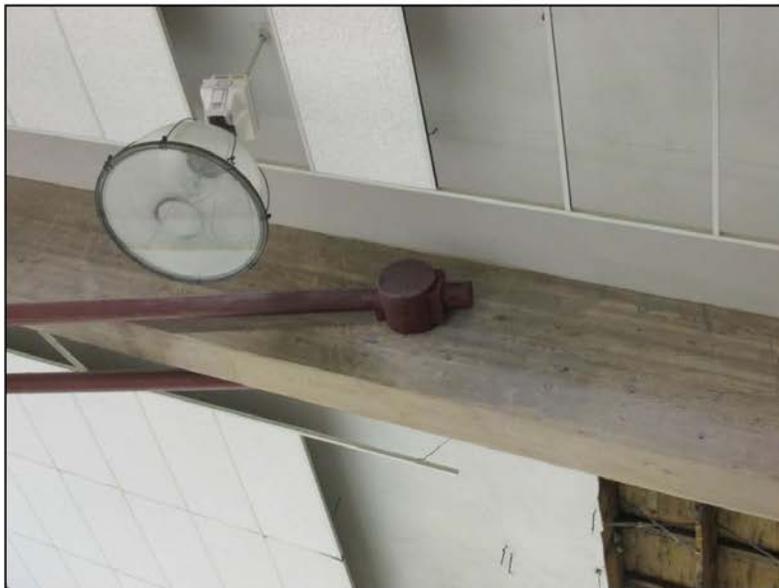
Photo 18: Typical Steel Collar Tie

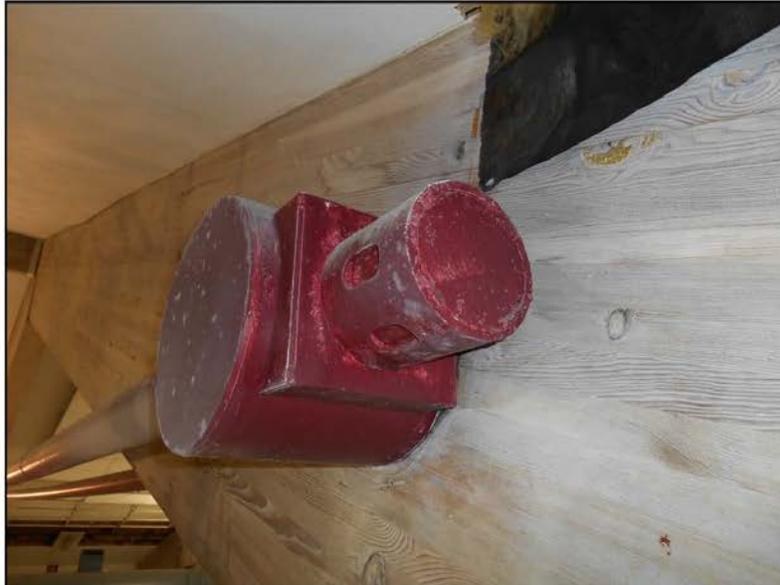
Photo 19: Typical Steel Collar Tie

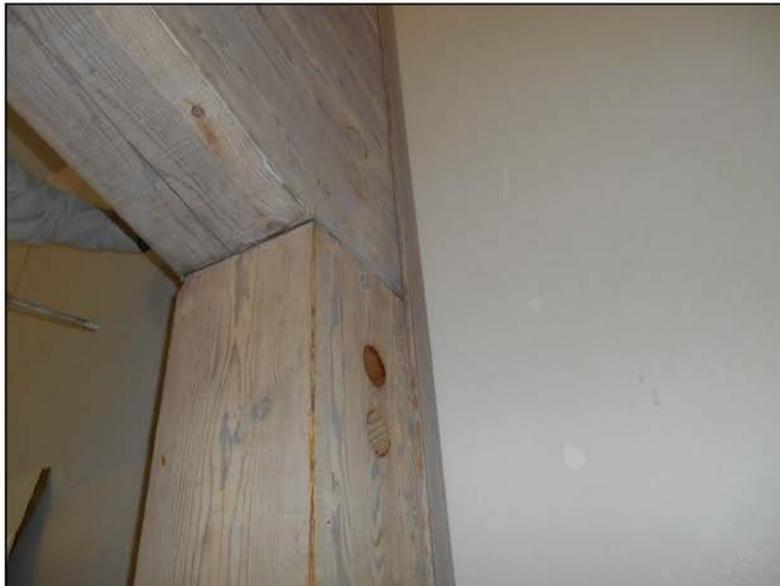
Photo 20: Typical Glulam Column

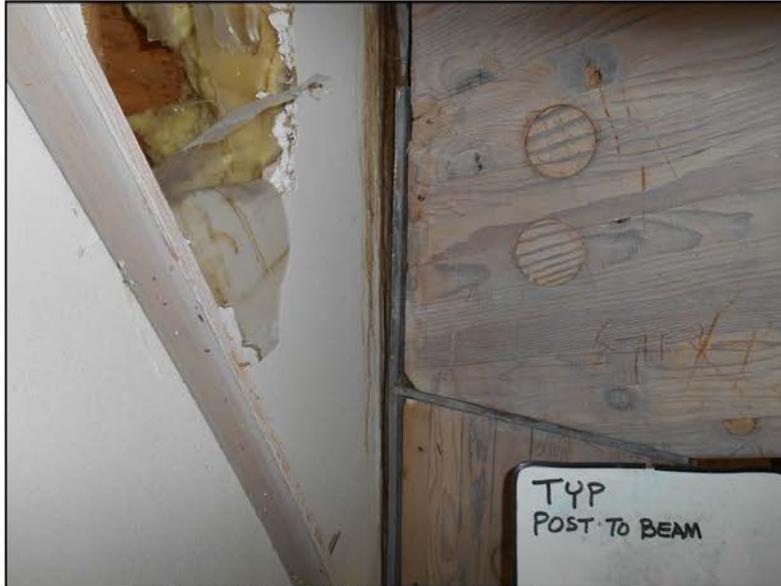
Photo 21: Typical Glulam Post-to-Beam Connection

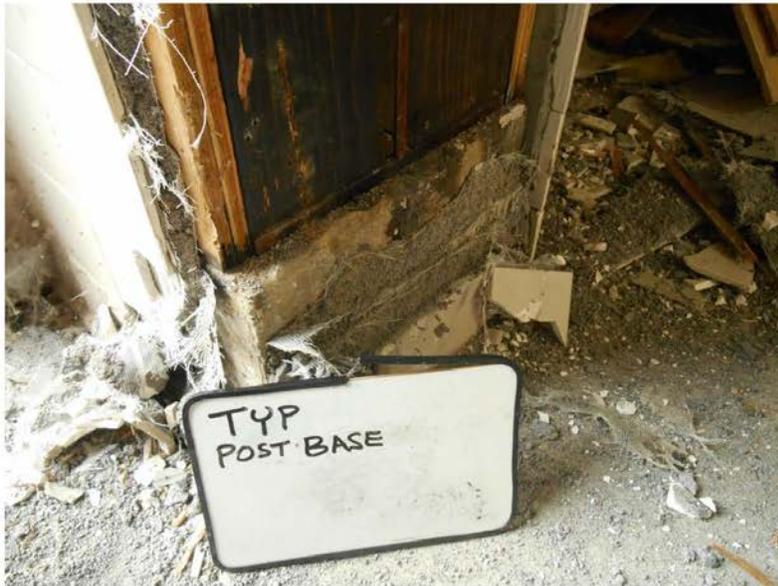
The glulam beams were supported by columns, which were supported on concrete foundation plinths with steel knife plates. Several column bases were exposed during the observation, and no water damage or rot was present. Refer to photos 22 and 23.

Photo 22: Typical Post Base (Stained not Moldy)

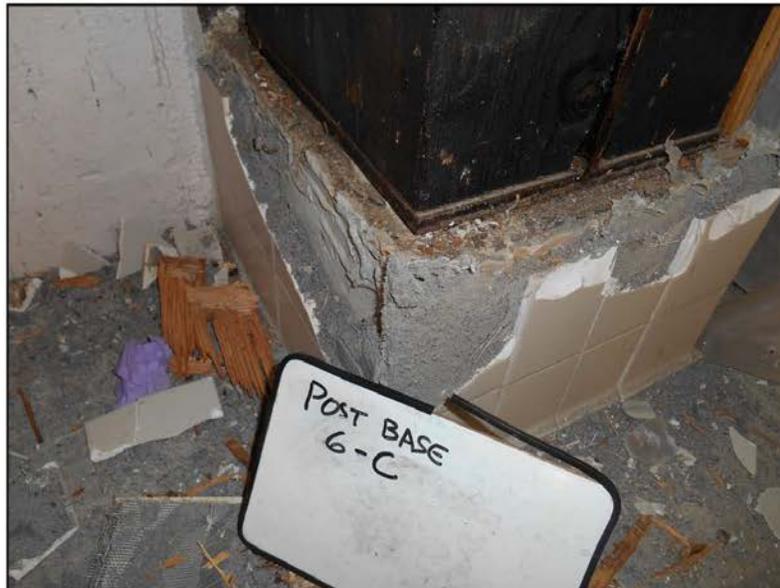
Photo 23: Post Base in Good Condition (Stained not Moldy)

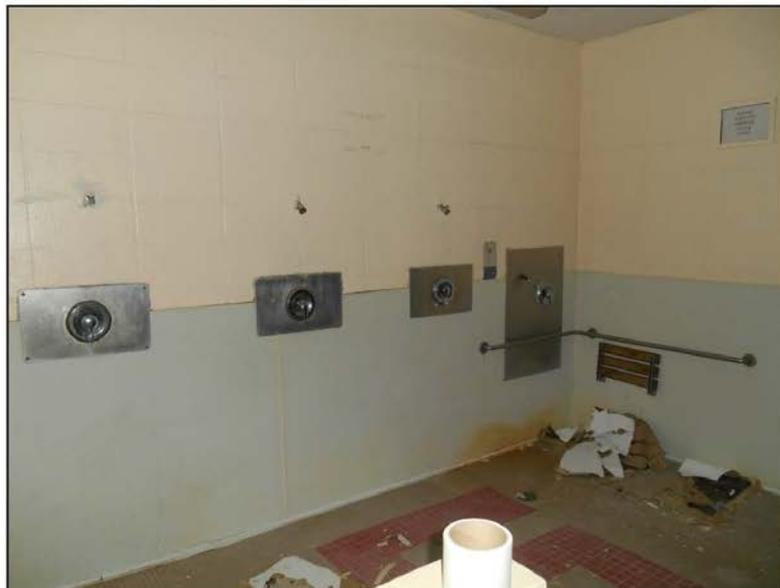
The lobby and locker rooms were constructed with masonry walls and a wood framed roof. The masonry walls were constructed with stacked bond (the masonry blocks were stacked vertically instead of staggering the masonry joints). Refer to photo 24. In each of the locker rooms, there was a distinct odor of mold and much of the debris on the ground was covered in mold. This is likely due to the building being vacant and unheated for several years.

The original construction drawings were reviewed for this area. Since the original construction of the pool building, the building codes have changed based on how standard construction practices have performed over time. The construction of the existing masonry walls no longer meets the requirements of the building code because they are prone to failure in a seismic event.

Photo 24: Locker Room with Stacked Bond Masonry

rooms. Given the type of construction, upgrading or remodeling this area of the building may not be possible or would likely be cost prohibitive. Demolition of the locker rooms and lobby is recommended.
