Hal Moe Pool Building

Structural Assessment

405 Third St.
Snohomish, WA 98290

CG Project No.: 14206.10

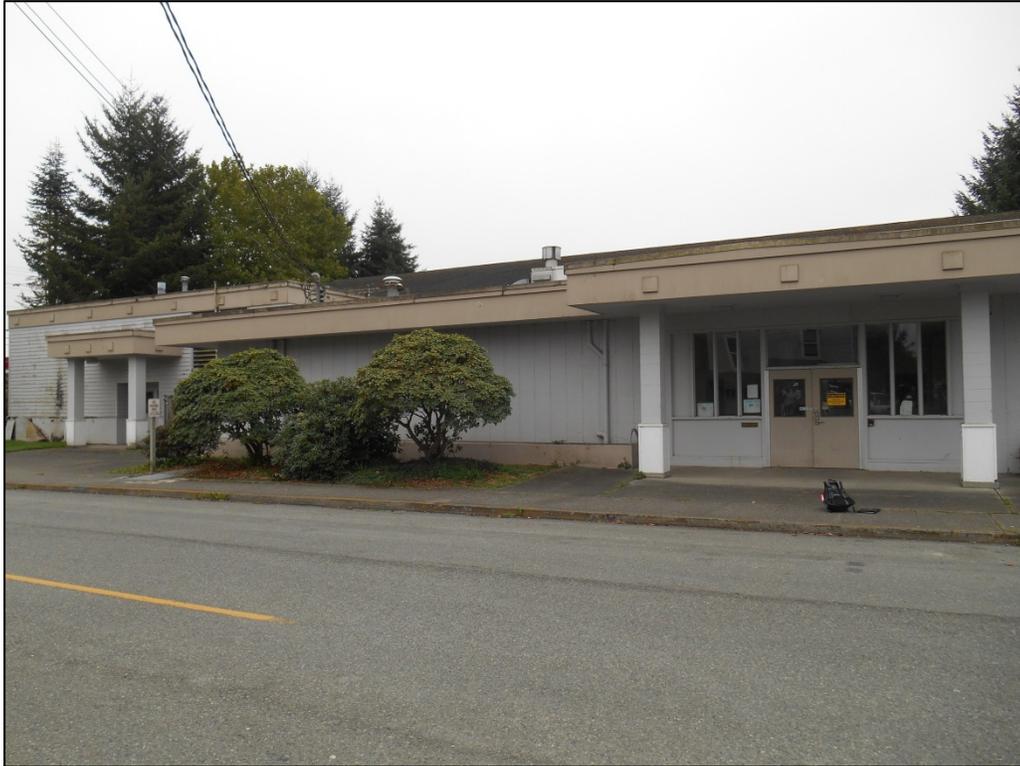
The pool building was closed in 2007 and has remained vacant since that time. The building includes a 14,000sf covered pool structure, and an attached 4,500sf locker room and lobby. The pool and changing rooms were constructed in the late 1960's and the covered pool structure was added in 1989. The locker rooms were constructed with masonry walls and a wood framed roof. Refer to photos 1-5.

Photo 1: Hal Moe Pool Entry North Elevation

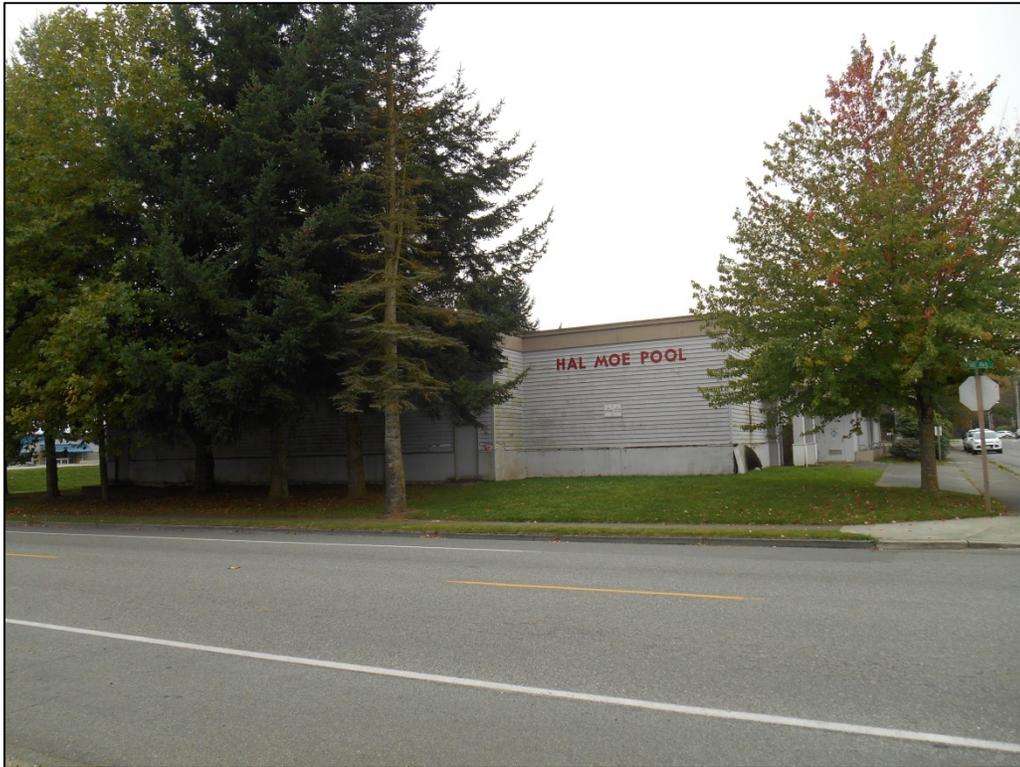
Photo 2: Hal Moe Pool East Elevation

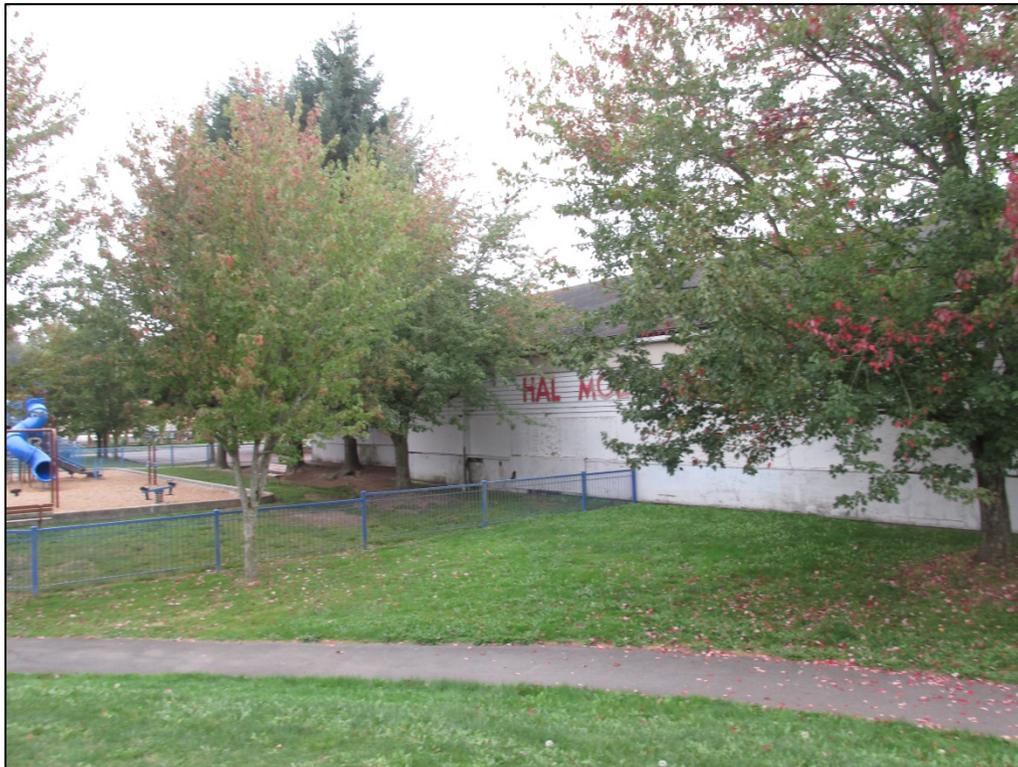
Photo 3: Hal Moe Pool South Elevation

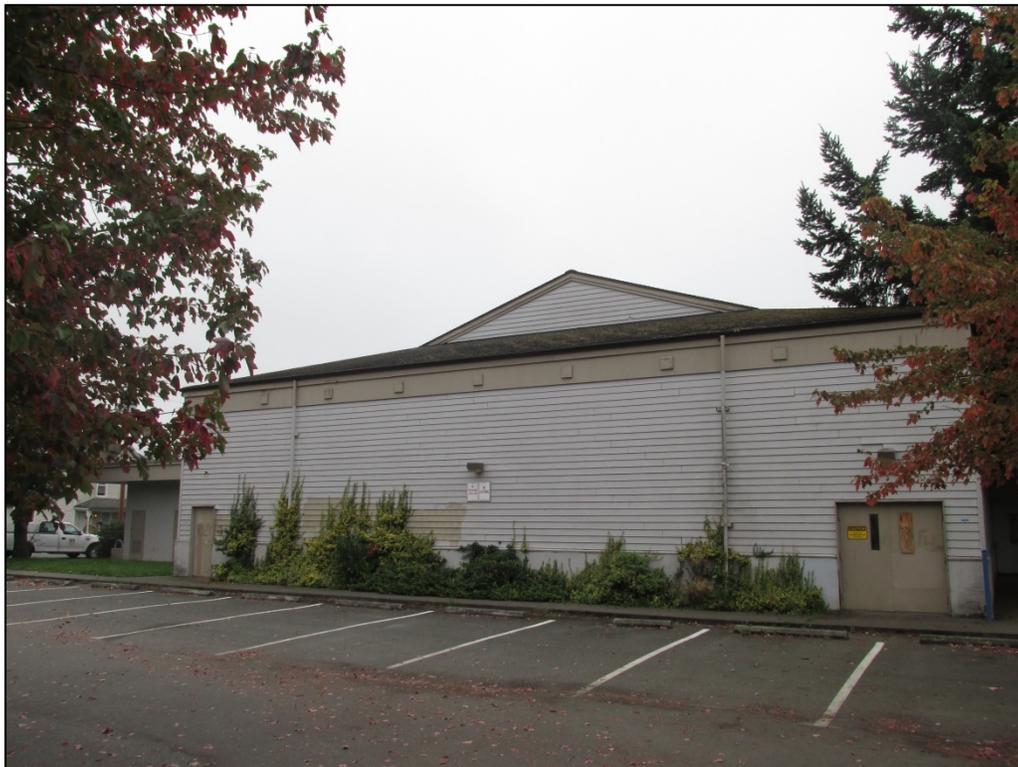
Photo 4: Hal Moe Pool West Elevation

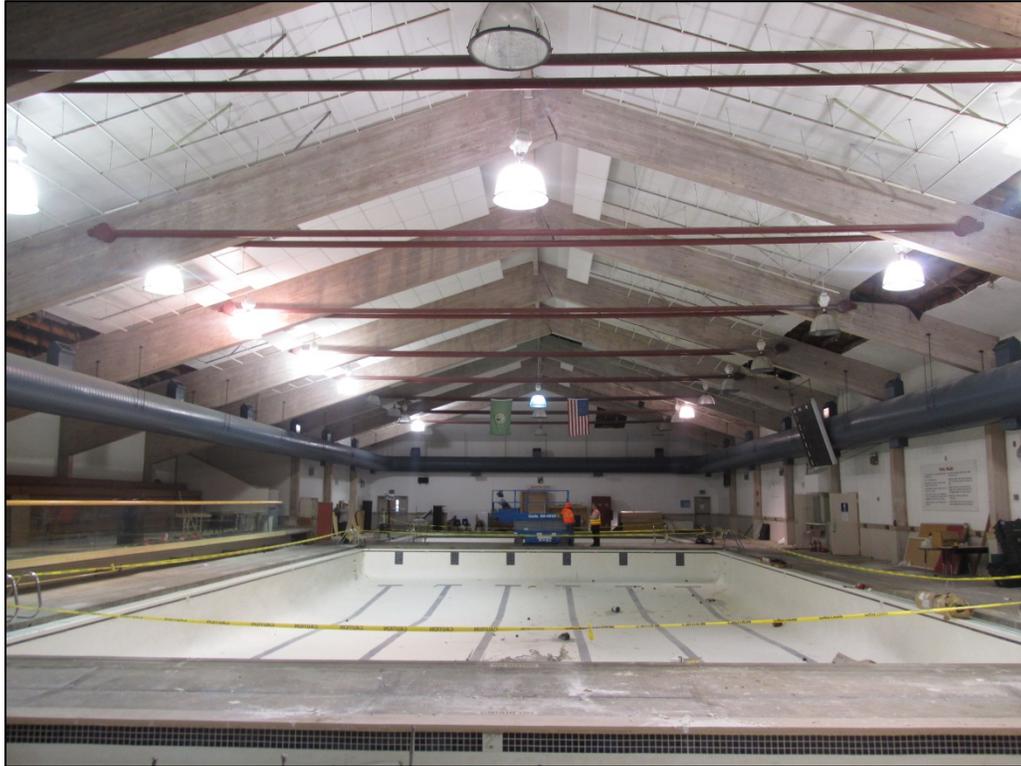
Photo 5: Pool Structure Interior

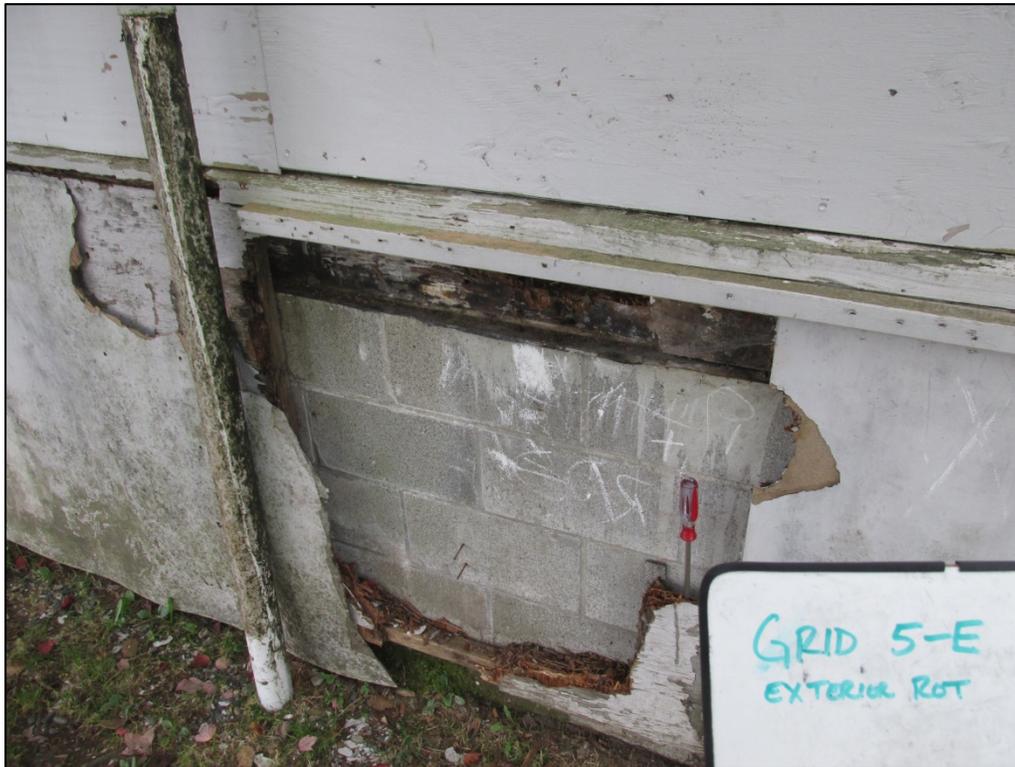
The exterior walls consisted of sheathed wood studs on top of masonry stem walls. Refer to photo 9. The masonry wall ran around the perimeter of the main pool structure. The exterior of the masonry was furred out with wood panel siding. Where side rooms were located off the main structure, the exterior walls consist only of wood studs and plywood sheathing. At several locations it was observed that the exterior siding was severely rotted. Refer to photos 10 and 11. While this condition was common around the perimeter, it seemed especially prevalent at locations where the roof gutter pipes were missing.

Photo 9: Lower CMU Wall with Stud Wall Above

The exterior of the building was constructed from a combination of wood and masonry walls. In the observation of the exterior, several locations of water damage and rot were found. The entire exterior wall system will need to be demolished and reconstructed. Typically, the exterior walls also support roof load and reconstruction of the exterior walls would require temporary shoring of the roof structure, causing additional labor during construction. In the case of this building, the roof structure is entirely supported by the glulam beams, alleviating the need for temporary shoring and allowing easier construction. Reframing the exterior walls would also allow for the opportunity to add doors and windows to the exterior. With the height of the roof framing, large roll up doors could be installed on either end of the building.

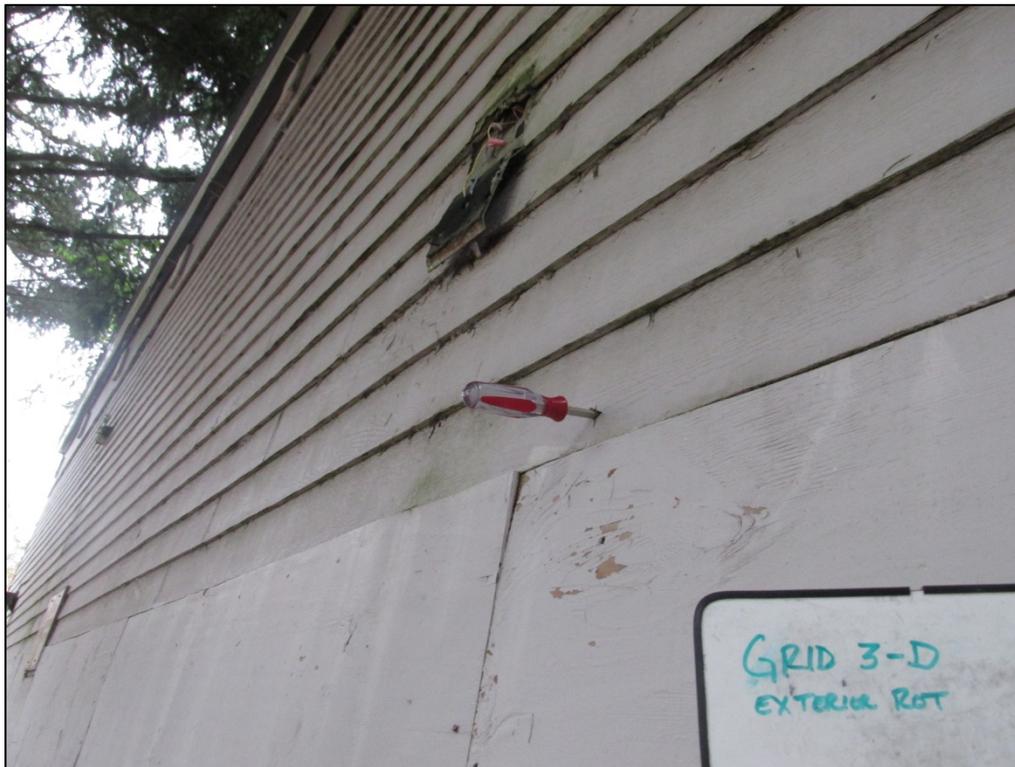
Photo 10: Exterior Siding Rot

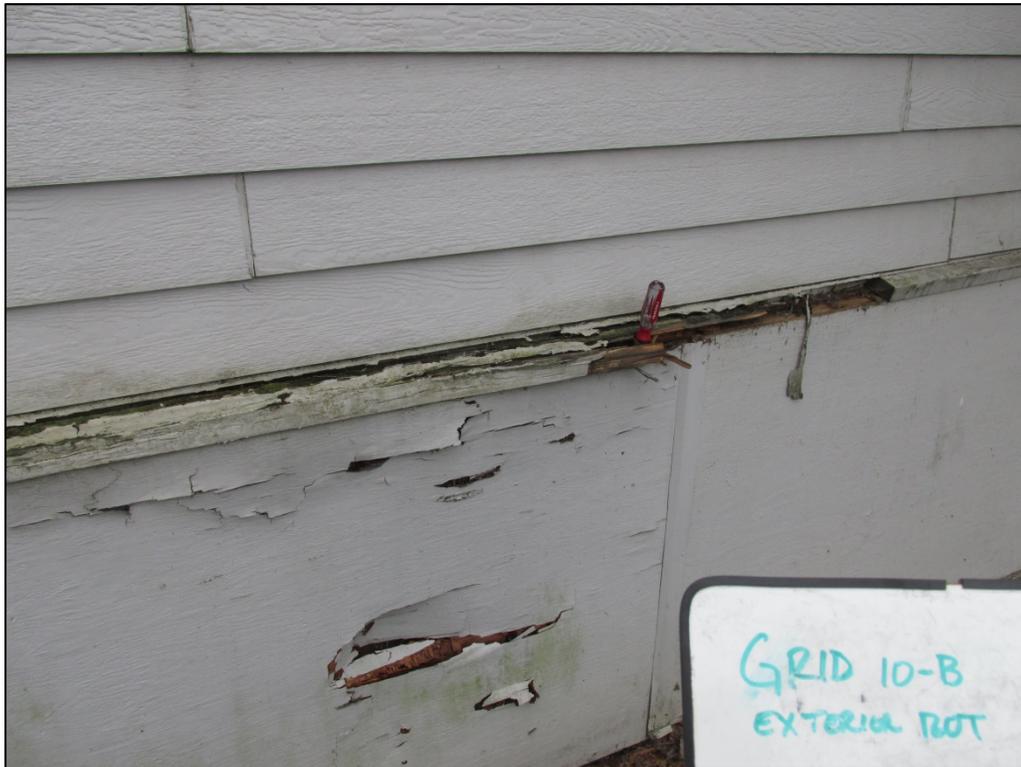
Photo 11: Exterior Siding Rot

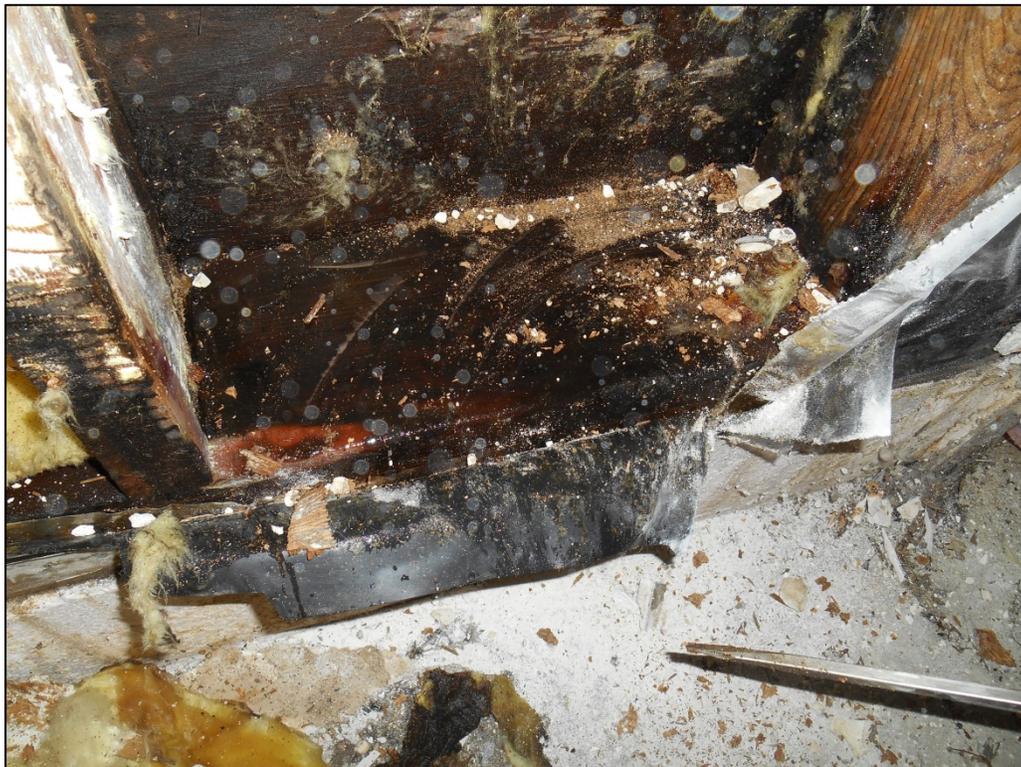
The wall cavities were opened during the assessment and observed. A vapor barrier was located on both the interior and exterior face of the studs. At the location opened, the wall cavity was damp and mold was observed. Rot was also present in the studs. Refer to photos 12 and 13. When a vapor barrier is applied to both the interior and exterior of a wall, it is common to have significant water damage without continual maintenance. The interior vapor barrier was likely required to protect the framing from the humid air caused by the pool. When the vapor barrier was punctured the water vapor in the air was allowed to enter the wall cavity, and then was not

able to escape causing the water to remain inside the wall cavity. It is likely that over the life of the building, small punctures occurred in the vapor barrier resulting in increased moisture inside the wall cavity.

Photo 12: Sill Plate Damp and Moldy

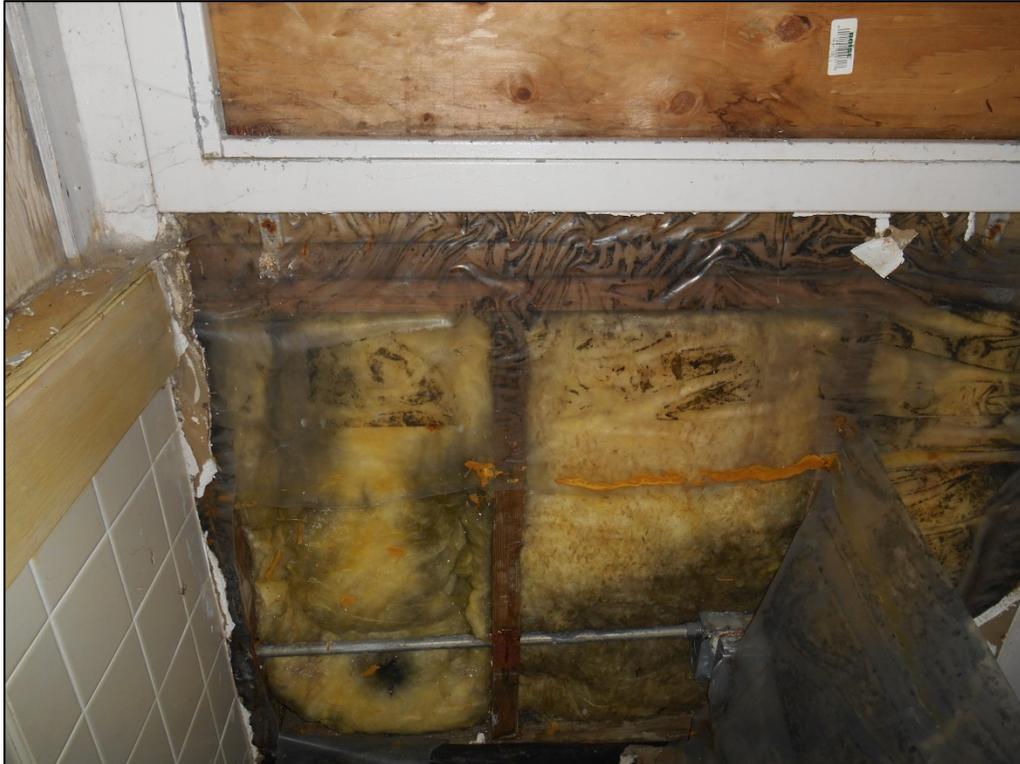
Photo 13: Mold in Stud Cavity

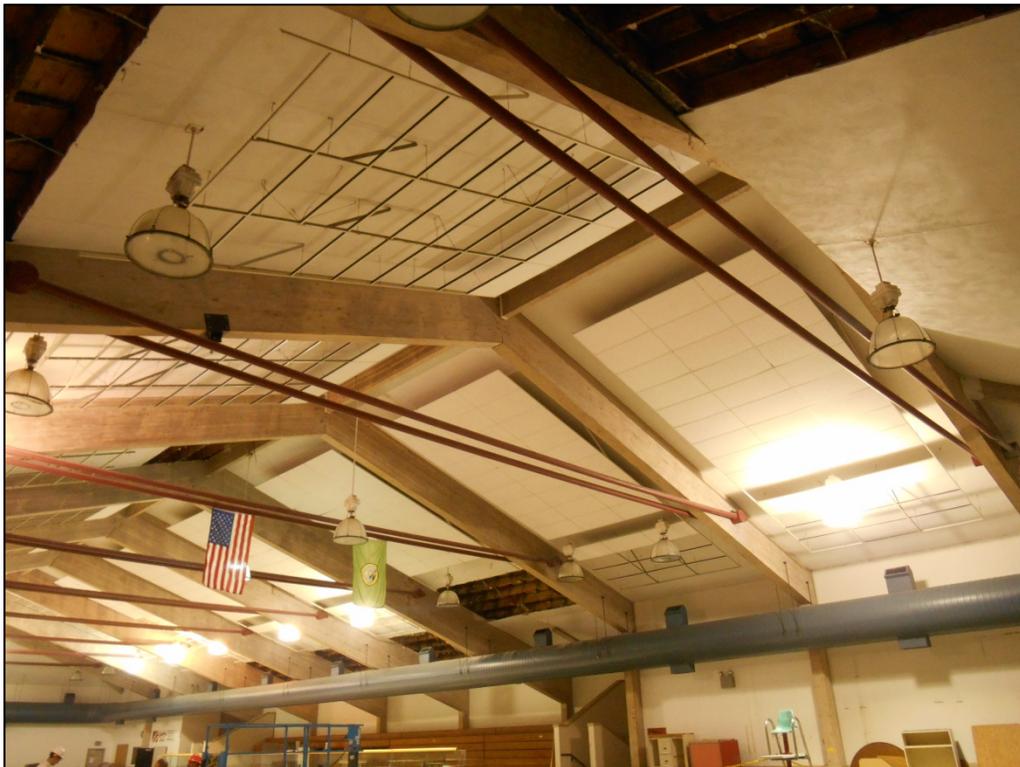
The roof structure consisted of roof sheathing nailed to flat 2x4 sleepers that were supported at intermediate, and end locations by roof rafters. The roof rafters spanned between glulam roof beams. The glulam beams were supported by glulam columns on the interior side of the exterior walls. Refer to photo 14.

Photo 14: Typical Pool Structure Framing

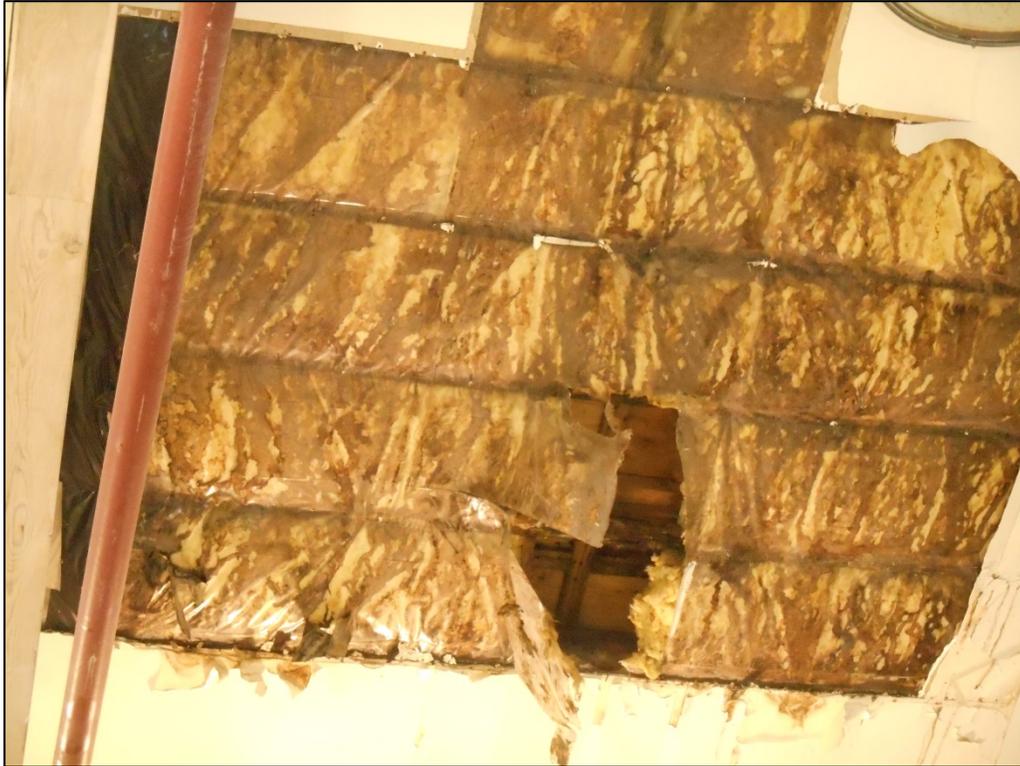
In many areas, the interior ceiling finish had fallen away exposing the roof framing and insulation. An interior and exterior vapor barrier was also installed on the roof. In many areas, the interior vapor barrier was exposed and the insulation was visible. In each of these locations mold was visible, and it appeared that water was trapped in the roof cavity. Refer to photo 15

Photo 15: Mold in Ceiling Cavity

The roof sheathing was damaged in several areas. Given the amount of damage, it is recommended that all of the roof sheathing and roofing be replaced. Almost all of the joists observed were affected by mold and some were also rotted. While the extent of the rot was minor, the amount of mold was extensive. Structurally, many of the joists are adequate, but it is recommended that any budget for remodeling include complete replacement of the joists. Given the cost of cleaning the mold and selective replacement, it will likely be more cost effective to replace all of the joists.

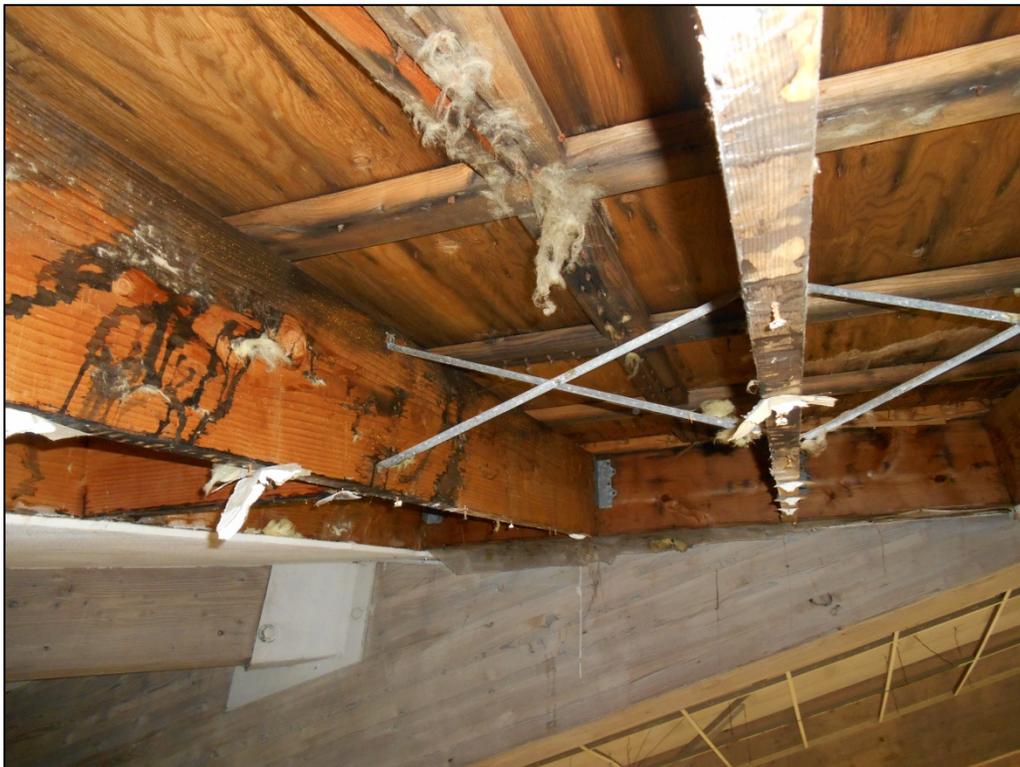
The roof joists were 2x12s spaced at 2'-0" on-center, and were observed from below where the interior ceiling finishes had fallen away. The locations observed showed signs of heavy water staining, mold, and minor rot. Refer to photo 16. The joists were supported at each end by a glulam beam, and were constructed with blocking between roof joists above the glulam beam.

Photo 16: Typical Roof Framing

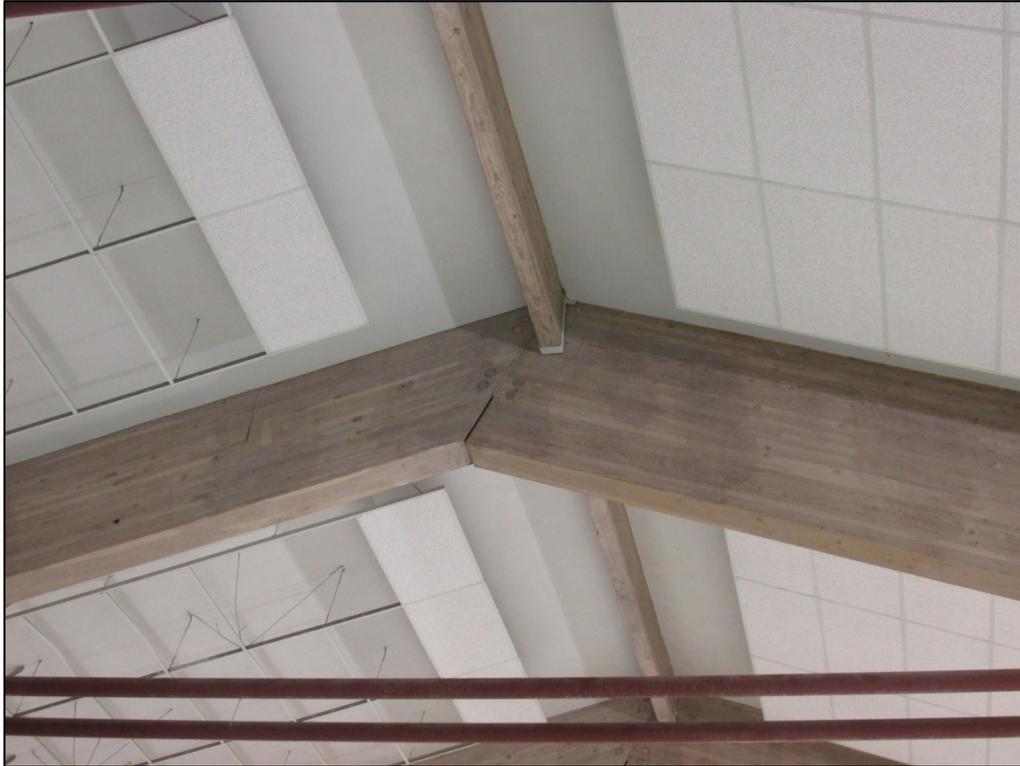
The glulam roof beams (10 3/4 x 36 north side spanning 35'-0", 10 3/4 x 48 south side spanning 47'-0") follow the slope of the roof, and were connected at the ridge by a bolted knife plate. There was also a steel collar tie connecting the glulam beams. At the time of the observation the glulam roof beams appeared to be in good condition, and there was no observable water damage or rot present. Refer to photos 17-21.

Photo 17: Typical Roof Beam

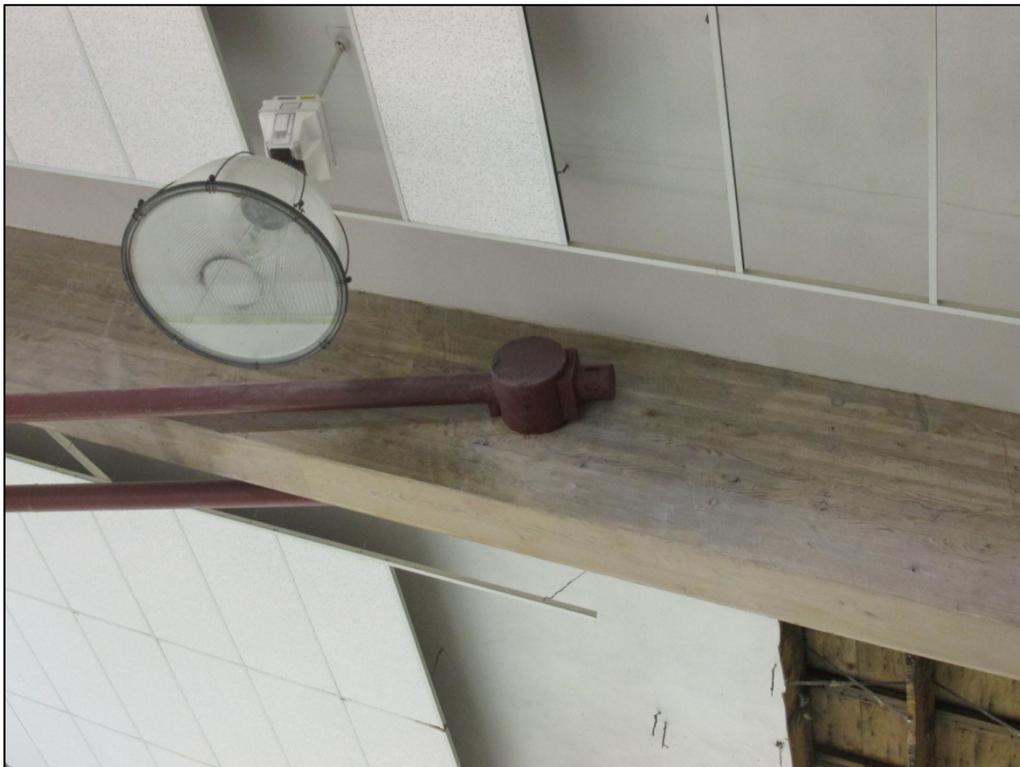
Photo 18: Typical Steel Collar Tie

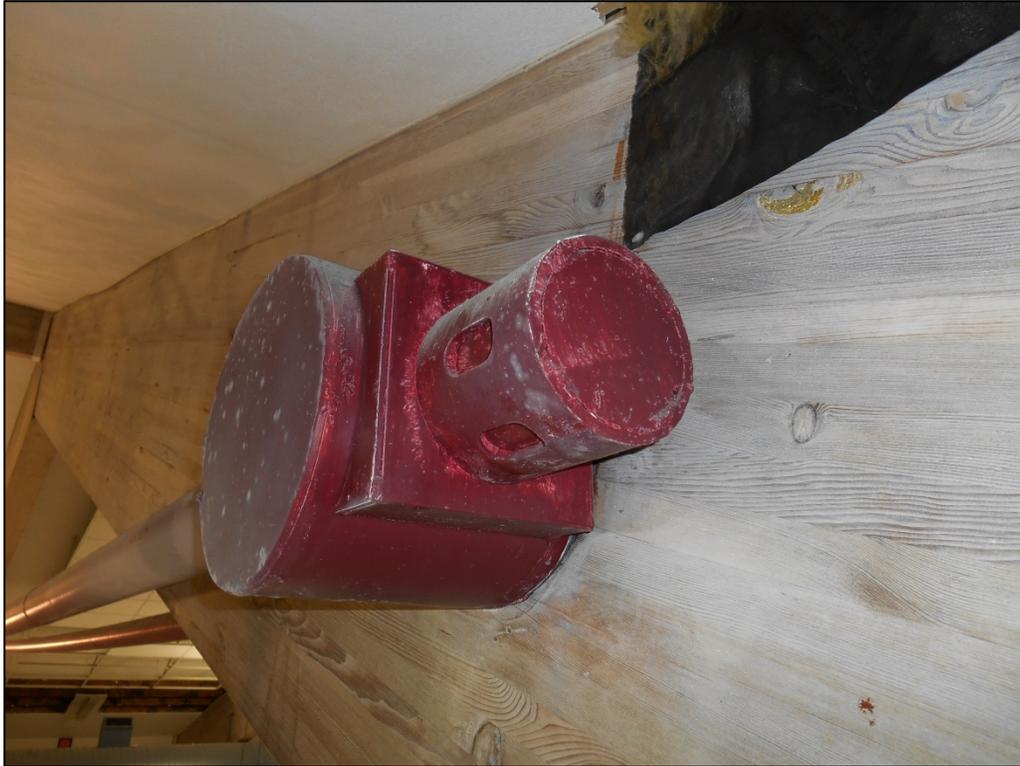
Photo 19: Typical Steel Collar Tie

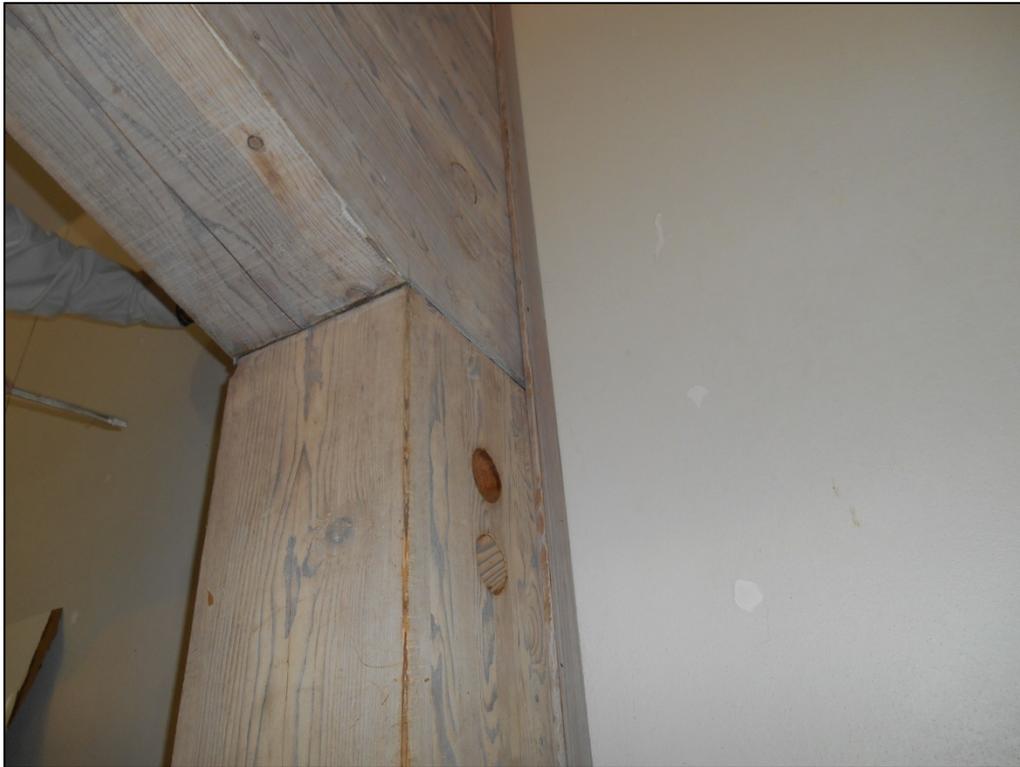
Photo 20: Typical Glulam Column

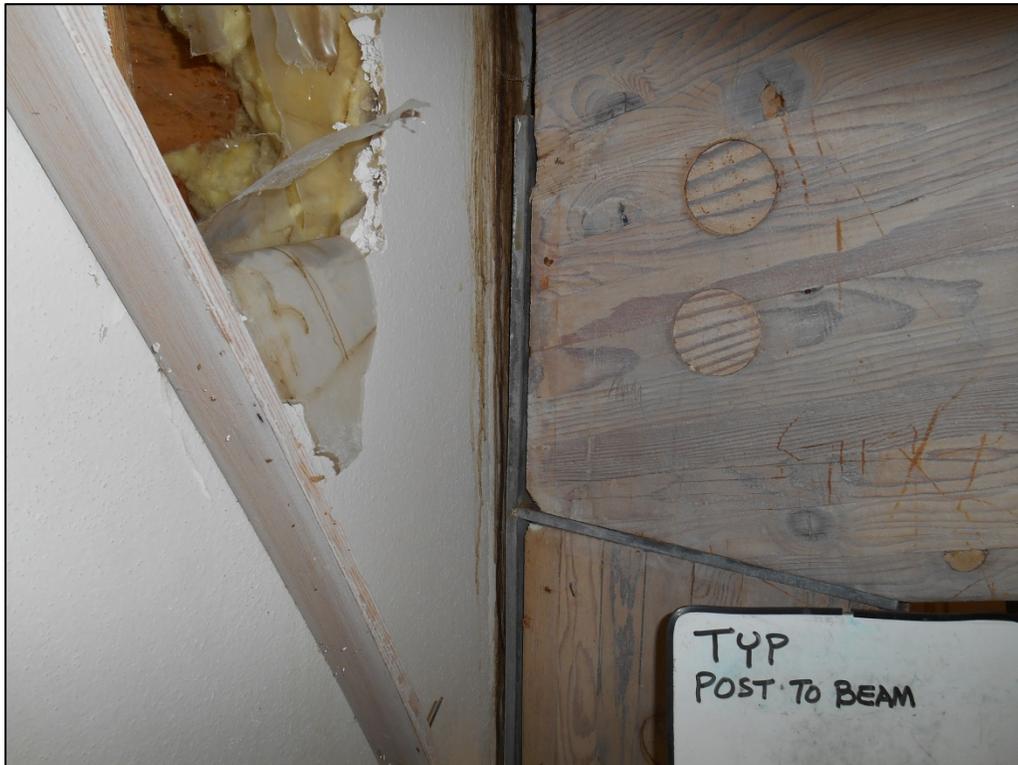
Photo 21: Typical Glulam Post-to-Beam Connection

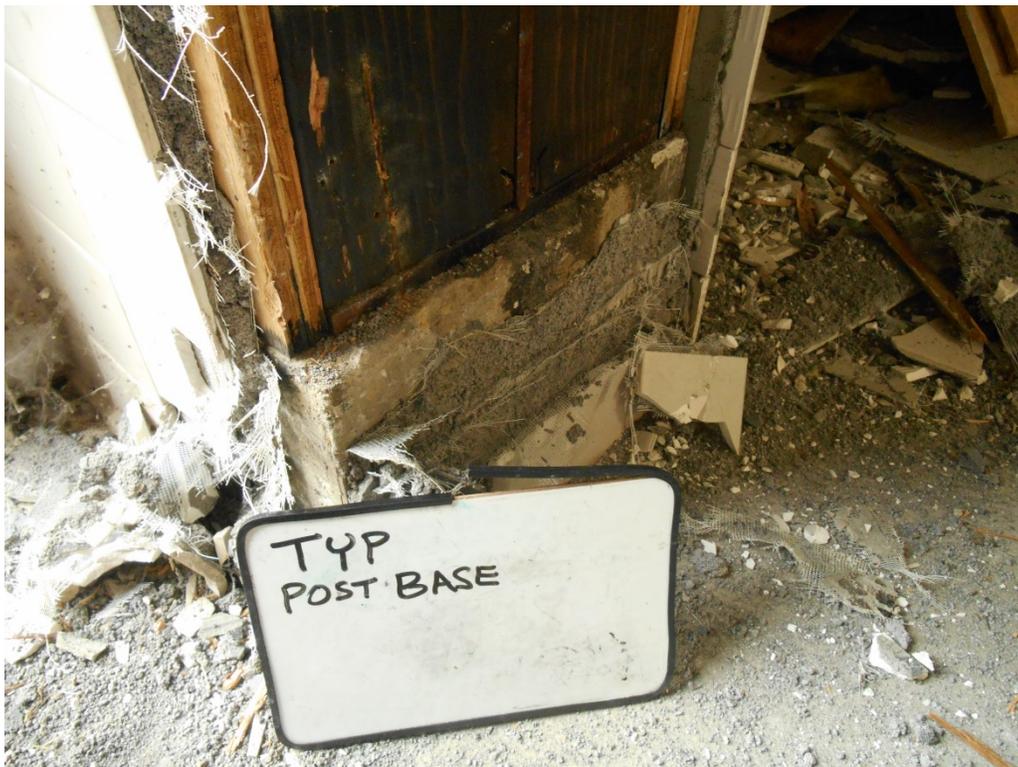
The glulam beams were supported by columns, which were supported on concrete foundation plinths with steel knife plates. Several column bases were exposed during the observation, and no water damage or rot was present. Refer to photos 22 and 23.

Photo 22: Typical Post Base (Stained not Moldy)

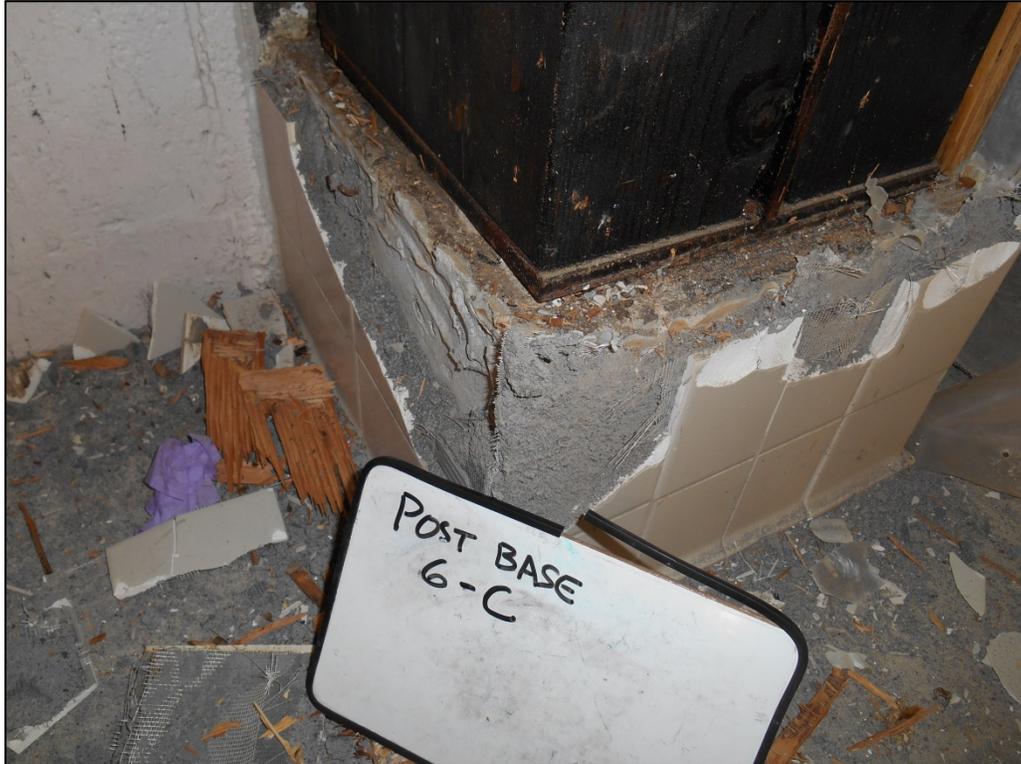
Photo 23: Post Base in Good Condition (Stained not Moldy)

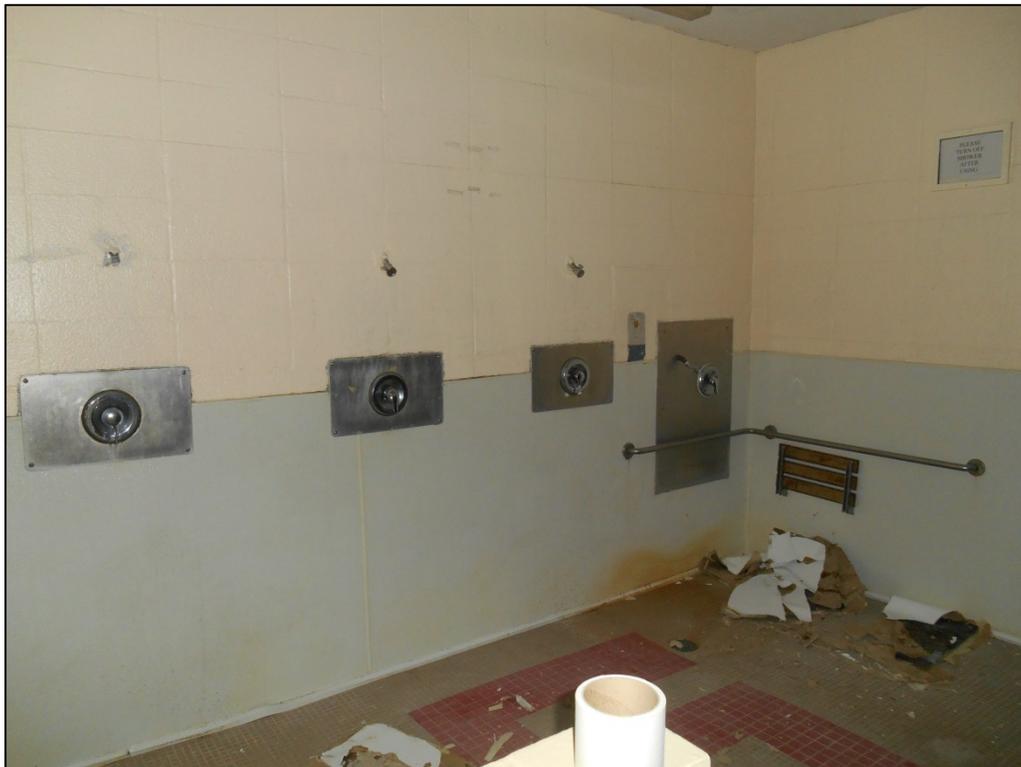
The lobby and locker rooms were constructed with masonry walls and a wood framed roof. The masonry walls were constructed with stacked bond (the masonry blocks were stacked vertically instead of staggering the masonry joints). Refer to photo 24. In each of the locker rooms, there was a distinct odor of mold and much of the debris on the ground was covered in mold. This is likely due to the building being vacant and unheated for several years.

The original construction drawings were reviewed for this area. Since the original construction of the pool building, the building codes have changed based on how standard construction practices have performed over time. The construction of the existing masonry walls no longer meets the requirements of the building code because they are prone to failure in a seismic event.

Photo 24: Locker Room with Stacked Bond Masonry

rooms. Given the type of construction, upgrading or remodeling this area of the building may not be possible or would likely be cost prohibitive. Demolition of the locker rooms and lobby is recommended.
