Myricks Fork Inventory

FINAL Report

Steward and Associates

June 1, 2007

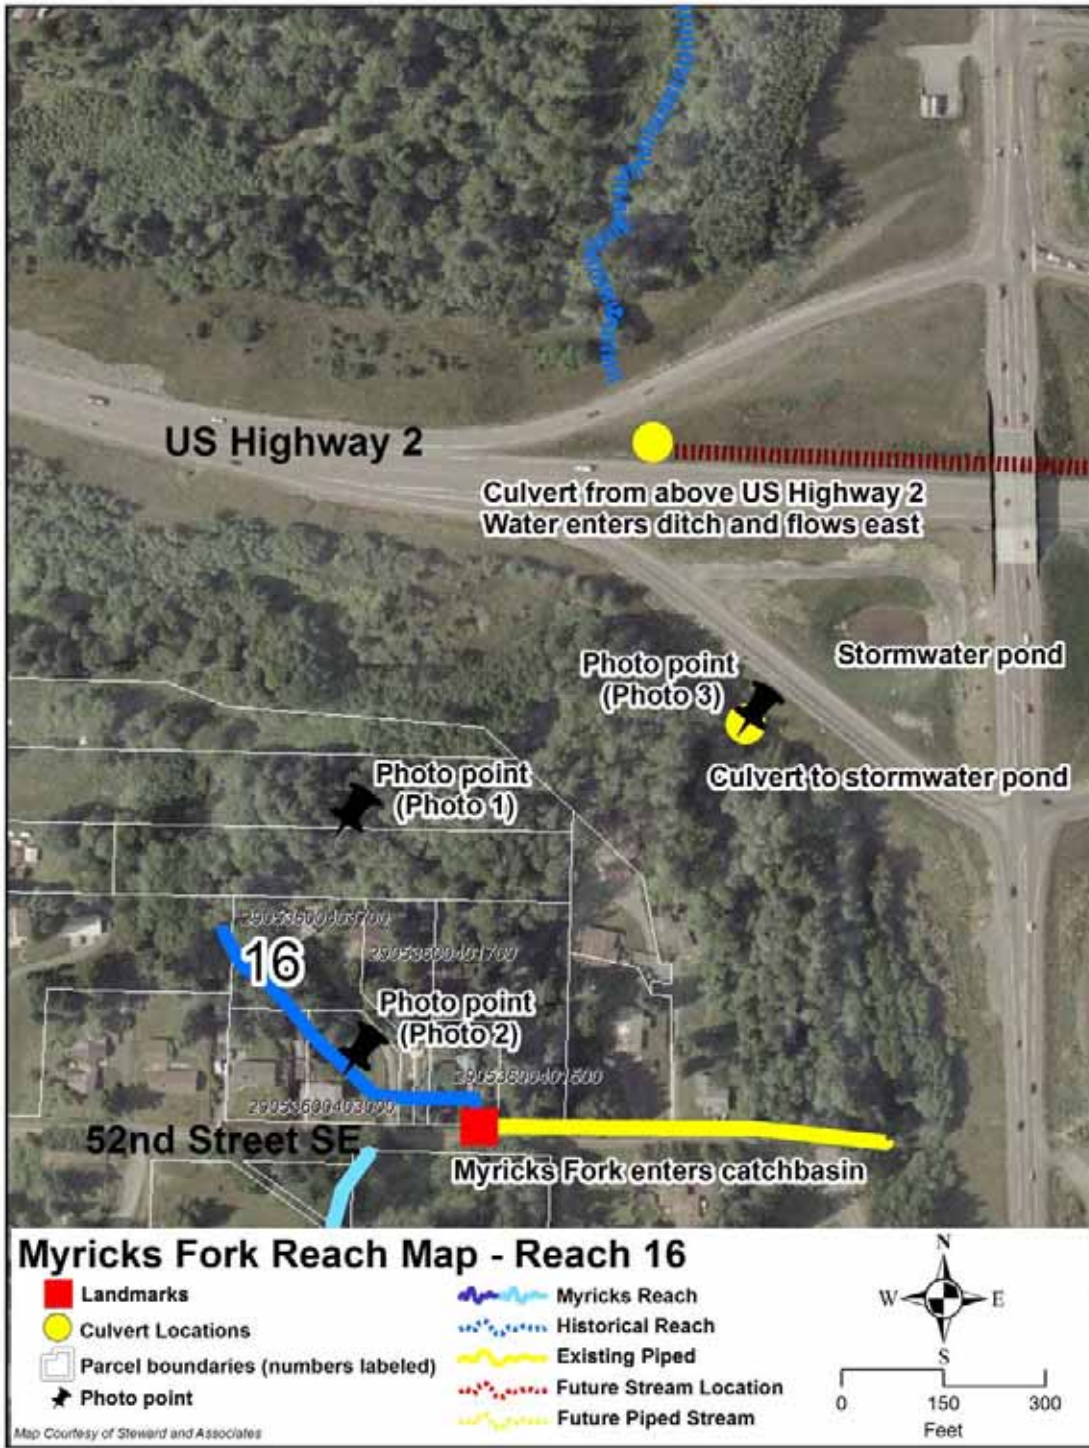
Figure 2. Map of Reach 16

From the catchbasin near the driveway entrance to parcel number 29053600401500, Myricks Fork water mixes with 52nd Street SE stormwater and is conveyed through a 12 inch stormwater pipe along the north side of 52nd Street SE to the east for over 400 feet before discharging to the western SR9 right-of-way (Figure 2). From here, the combined stormwater and Myricks Fork water seems to infiltrate or move slightly north during higher flows to eventually empty into a 24 inch corrugated metal culvert that carries water under the eastbound US2 off-ramp and into a stormwater pond north of the eastbound off-ramp, south of US2, and west of SR9 (Photo 3). The most recent Snohomish County Drainage Inventory map (2006) and further conversations with County Public Works staff were not able to provide information as to when this Myricks diversion occurred. County Public Works staff indicated that the 52nd Street SE catchbasin was likely installed at a time when records were kept by hand and thus does not show up in the County drainage inventory records. Regardless of when the catchbasin and subsequent diversion of Myricks Fork water occurred, it is apparent that the diversion robs the existing Myricks Fork channel of surface waters that historically flowed south to the Cemetery Creek watershed.

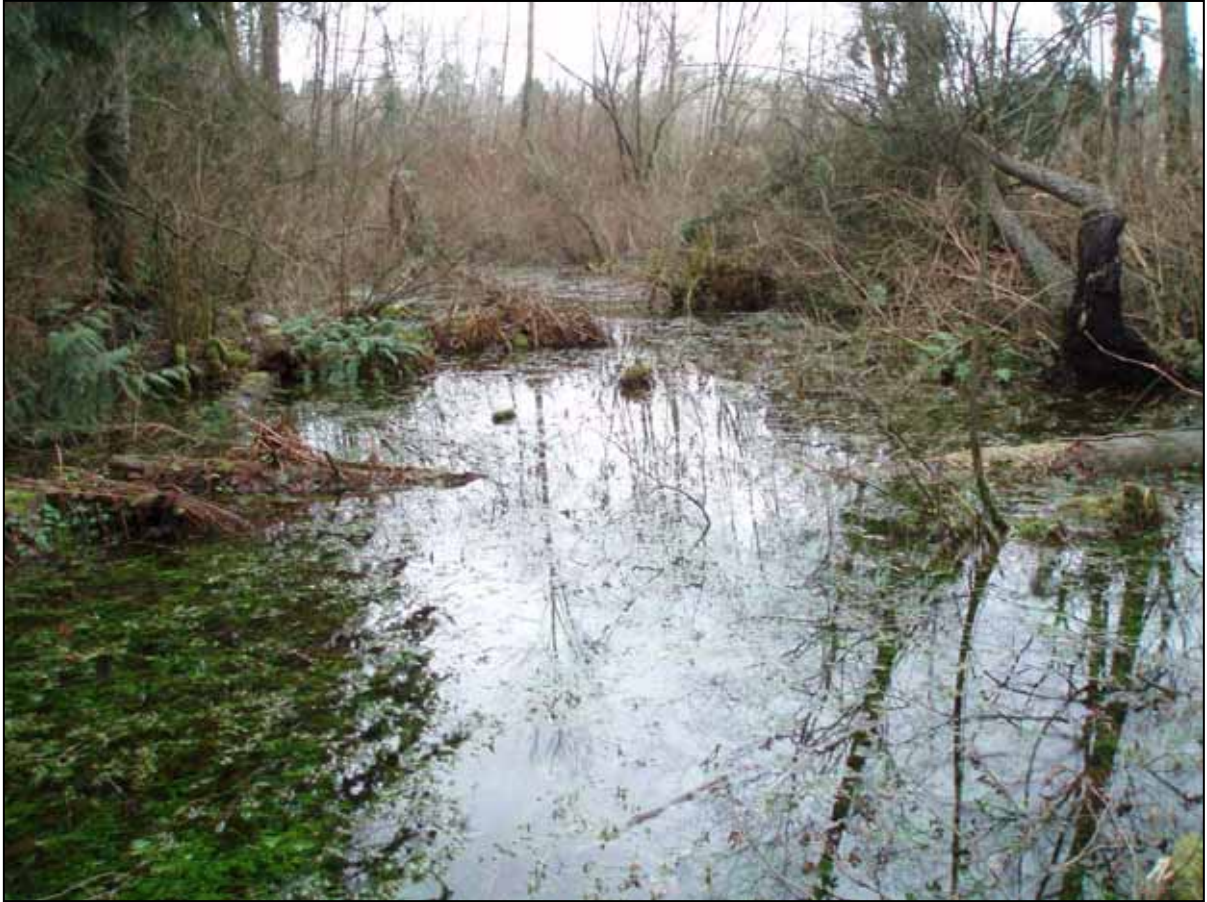
Photo 1. Reach 16. A portion of the wetland complex at the Myricks Fork headwaters.

At present, an extensive network of wetlands (Photo 1) located north of 52nd Street SE, south of US2, and west of SR9, represents the headwaters of Myricks Fork. Based on observed conditions and communication with Snohomish County public works staff, Myricks Fork historically flowed south from its headwater wetlands, past what is now 52nd Street SE, and through an area that is now a mobile home park and a residential subdivision (see Reach 15 below). Residential development and the construction of roads and driveways have changed the conveyance of Myricks Fork through this reach.

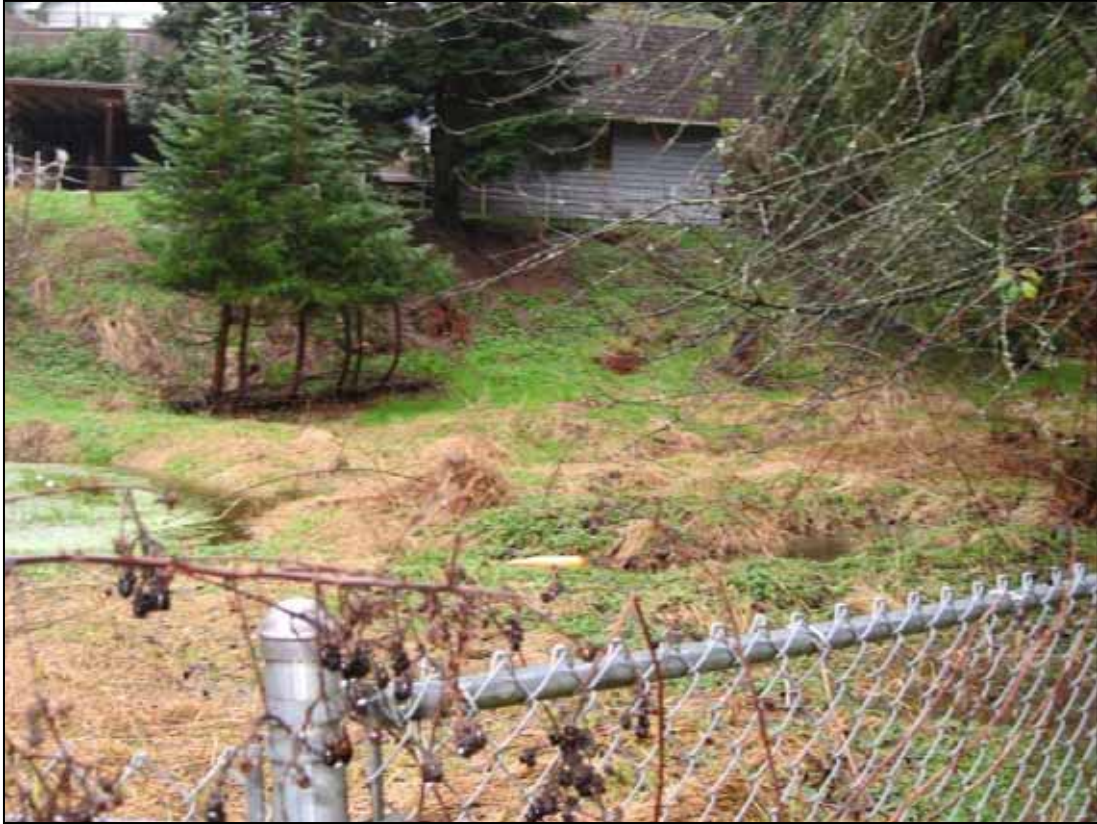
Photo 2. Reach 16. Myricks Fork enters pond on parcel 29053600403000.

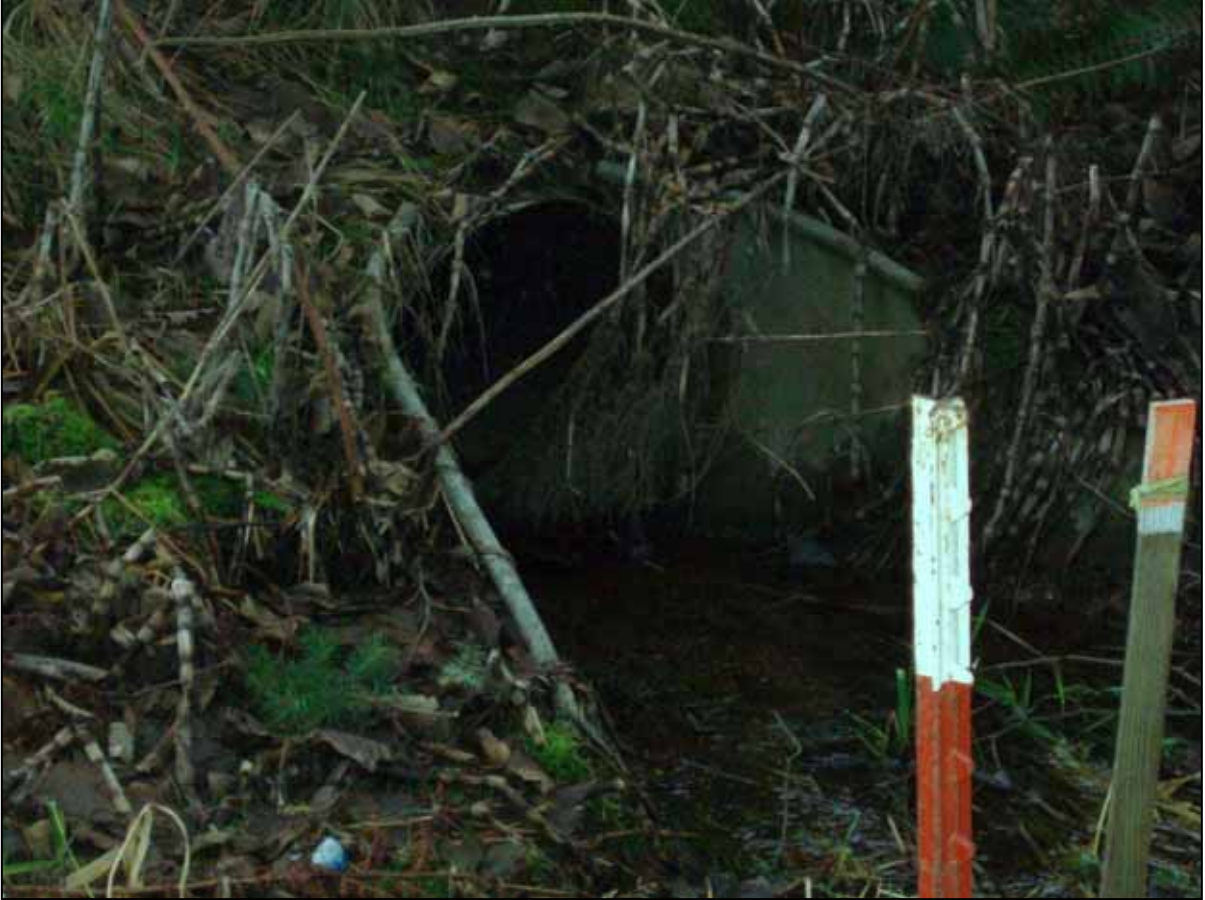
Photo 3. Reach 16. Myrick Fork, along with stormwater from SR9 and US2, enters 24 inch corrugated metal culvert leading under eastbound US2 off-ramp to stormwater pond.

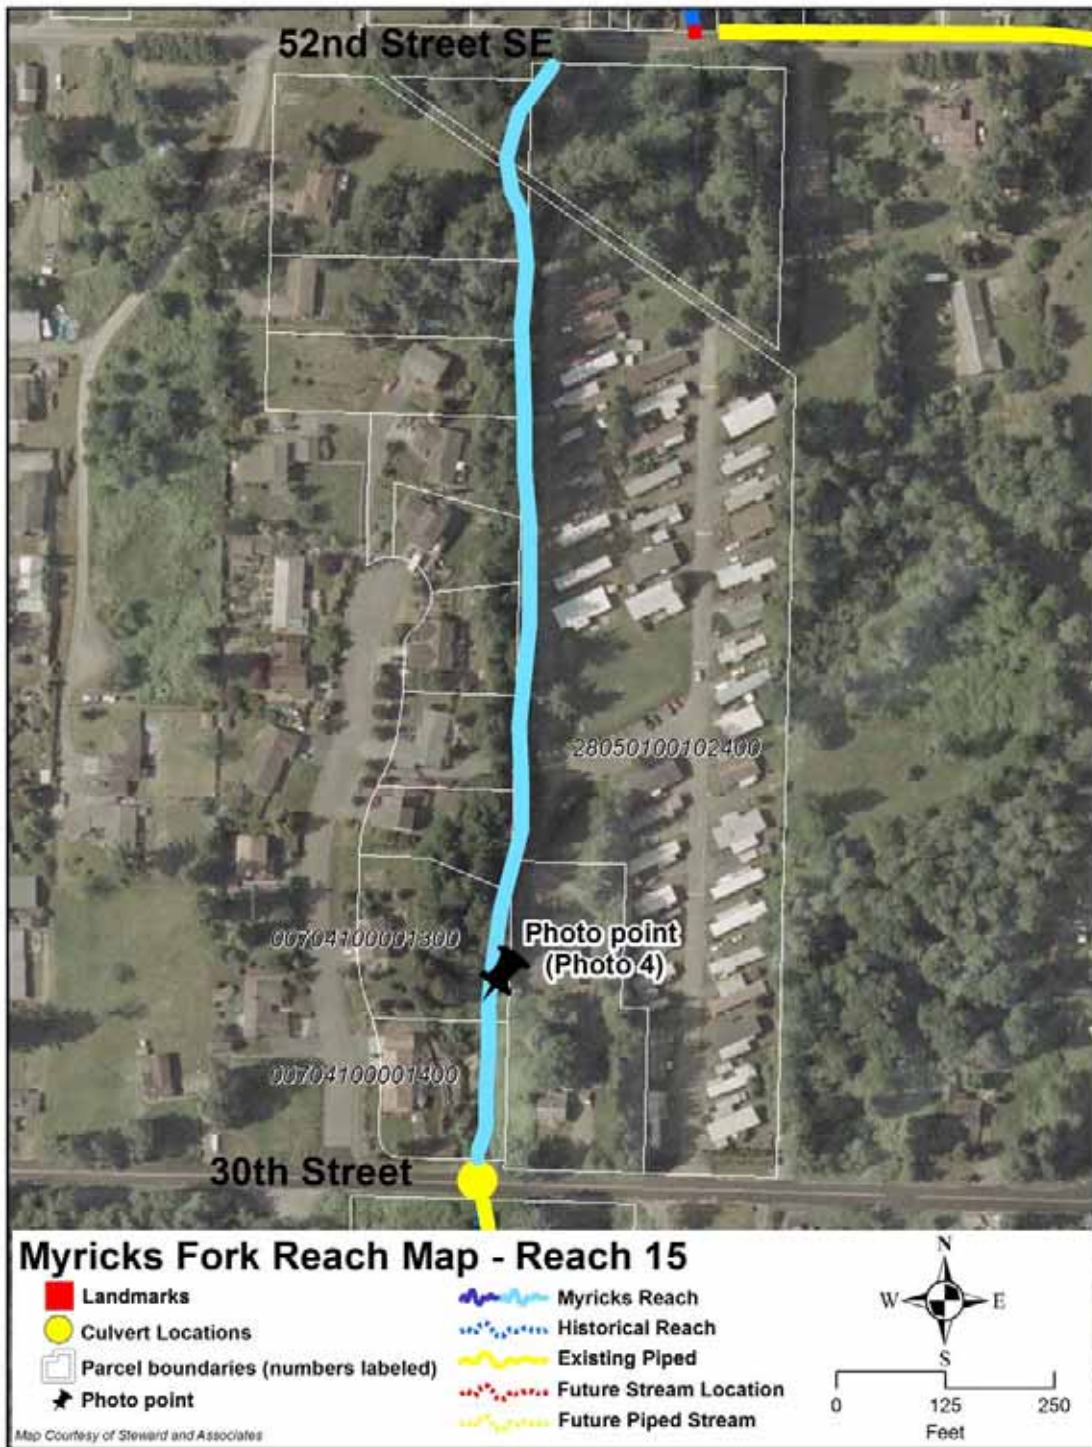
Figure 3. Map of Reach 15.

Just north of 30th Street we observed a wide ravine that is the obvious historic location of the Myricks Fork channel. Although water was absent from the ravine during our site visit, we presume that surface water does periodically flow due to the presence of a very faint stream bed and streambanks. We surmise that this surface flow is likely localized stormwater and perched groundwater. The ravine is almost entirely covered with Himalayan blackberry brambles and also contains a patchy forested canopy. A flow control device has been installed in the ravine just north of 30th Street to control the downstream stormwater discharge from the 93rd Drive SE subdivision. The device was apparently installed to detain stormwater from 93rd Drive SE during high flow events.

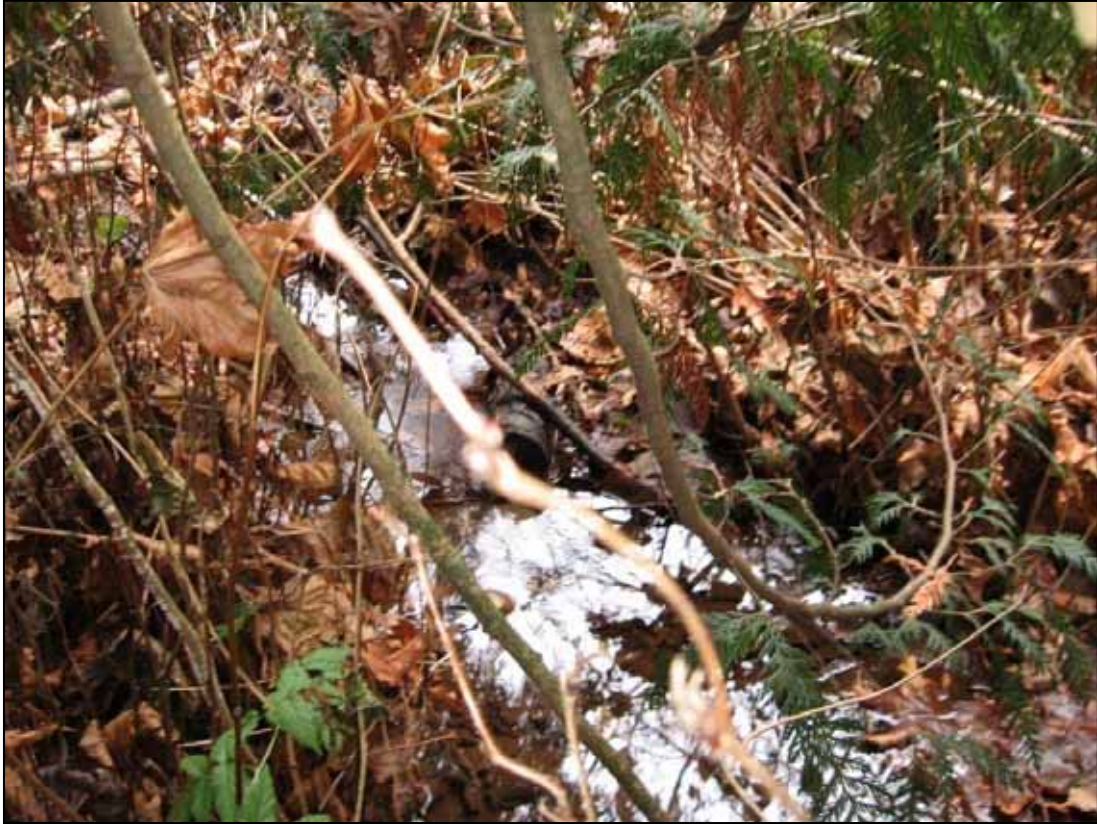
Photo 4. Reach 15. Short reach of surface water on parcel 00704100001300.

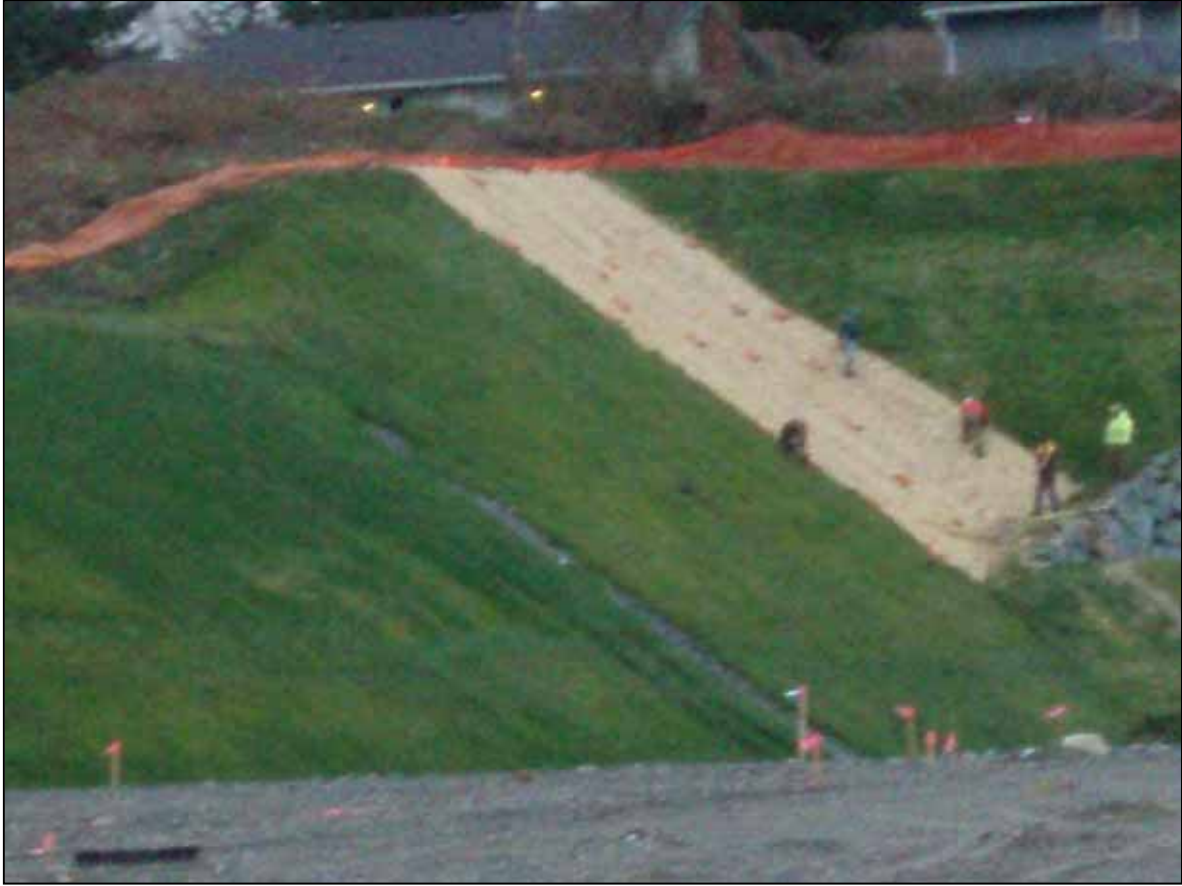
Photo 5. Reach 14. Crew works at northeast corner of development. Black tarp has been removed. Steward and Associates staff observed continuous groundwater flow emerging from the area one week prior to the date this picture was taken.

Steward and Associates staff found evidence of springs or groundwater emerging from the newly seeded embankment in the northeastern portion of the Snohomish Station – Phase I development site. Upon descending the steep grass bank, south from the blue Myricks Fork sign on 30th Street, we found the slope to be very saturated. Additionally, in the northeast corner of the development site we observed a light, continuous flow of groundwater emerging from an area covered with rocks and a black tarp (Photo 5). We observed no other flow along the east end of the project site until we reached the southeast corner, where we observed the end of the black 25 inch pipe containing the tightlined Myricks Fork flows described in the Reach 13 section below.

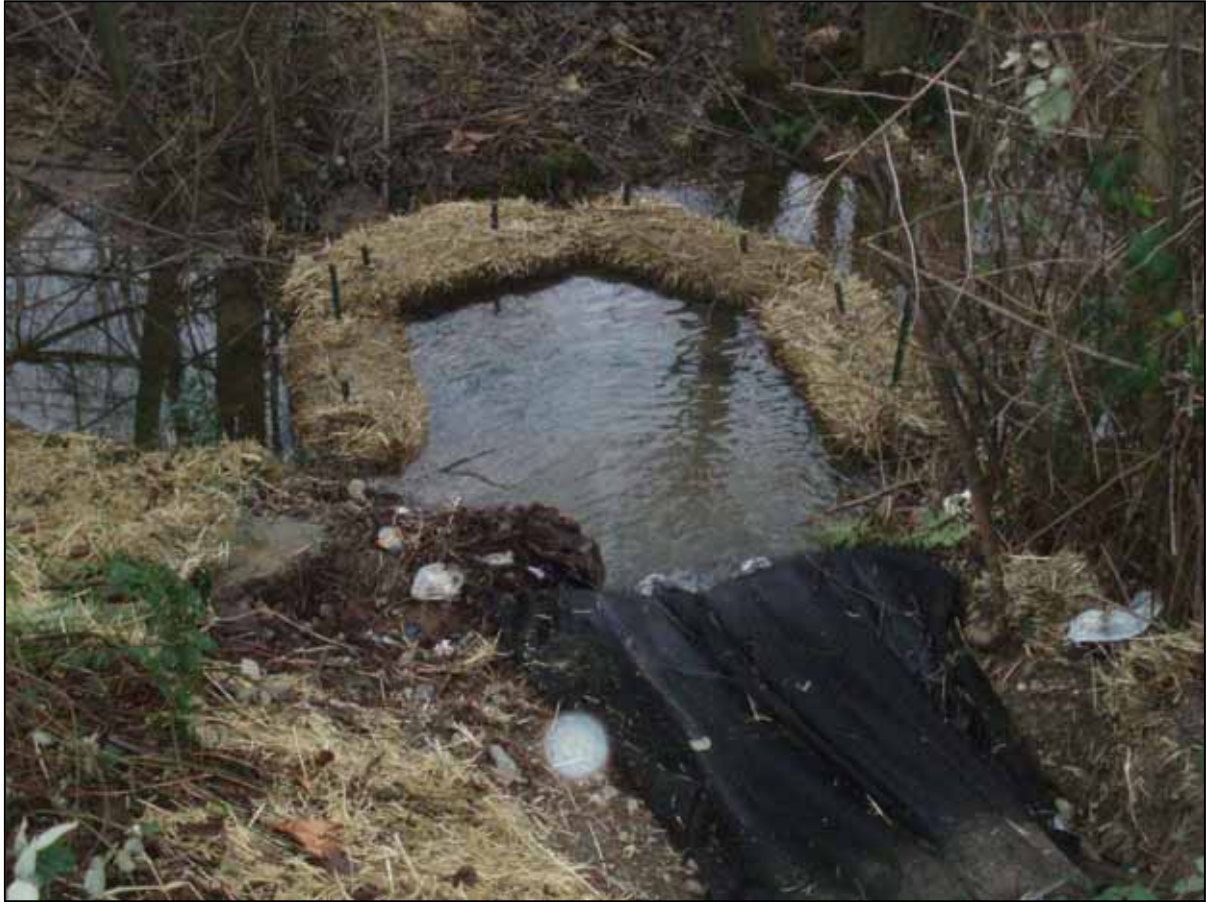
Photo 6. Reach 14. Water flowing under Bickford Avenue and into wetlands associated with Cemetery Creek.

At the west end of the Snohomish Station site we observed water flowing through a catchbasin and into a 24 inch metal pipe leading west under Bickford Avenue and into wetlands associated with Cemetery Creek (Photo 6). Judging from the flow volume and recent precipitation events at the time of our field visits, the flow under Bickford Avenue likely included existing stormwater and Snohomish Station project stormwater. At times of heavy flow, a generator-powered pump sucks water from the Bickford Avenue catchbasin (Photo 7) and pipes it through an 8 inch plastic pipe to the east end of the Phase I site where it can be infiltrated to groundwater rather than passing to Cemetery Creek as surface water. Steward and Associates staff were told by the project engineer that all spring flows that emerged as a result of the Snohomish Station development were infiltrated back to groundwater rather than transferred to surface water in an effort to maintain existing site conditions, as required by the Department of Ecology.

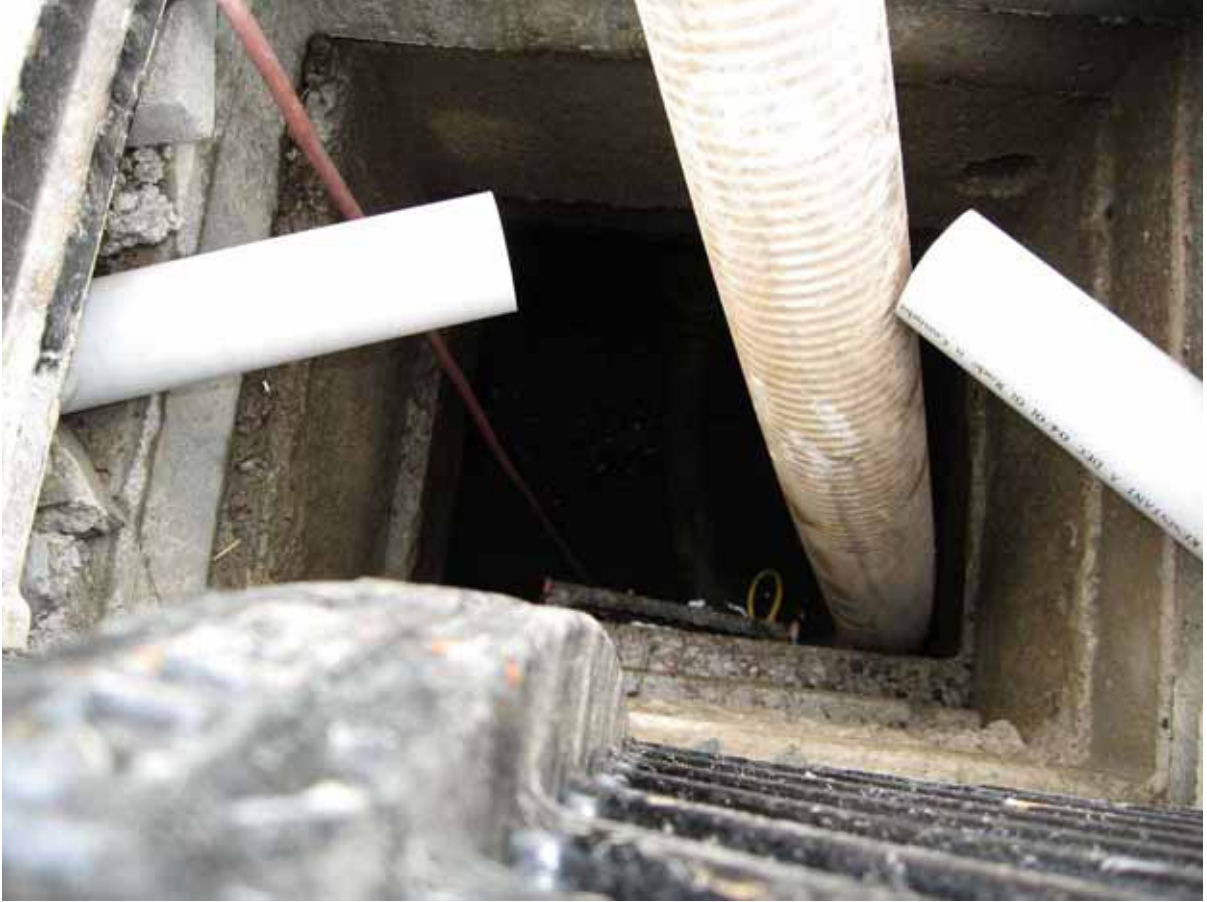
Photo 7. Reach 14. Eight inch plastic pipe pumping Snohomish Station project stormwater from the west to east end of the project site to infiltrate as groundwater.

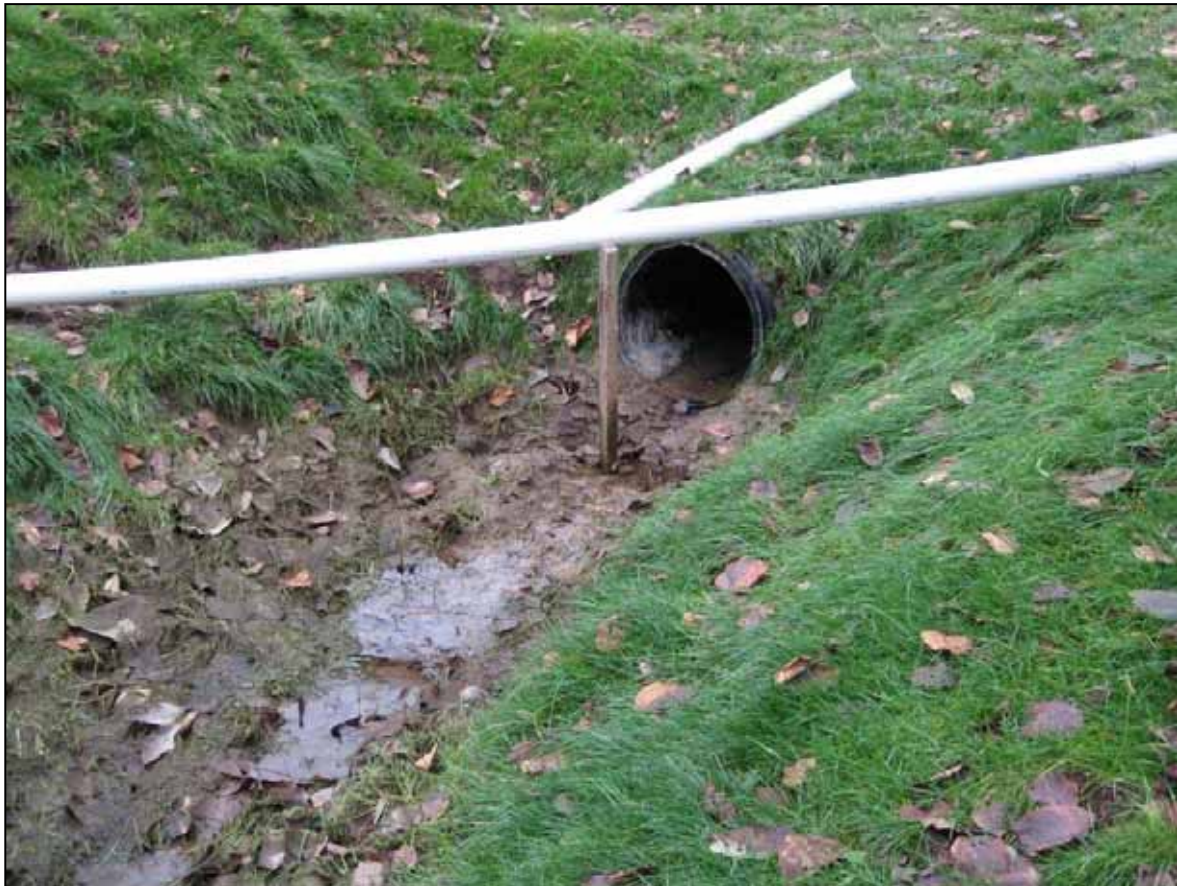
Photo 8. Reach 13. Black plastic pipe, 25 inches in diameter, at the southeast corner of Snohomish Station project.

In the southeast corner of the Snohomish Station project (parcel number 28050100103800) there exists a 25 inch black plastic pipe (described in previous section) that is connected at its north end to the Myricks Fork culvert beneath 30th Street. Steward and Associates staff observed very minimal flow emerging from the pipe and out into a silt-bottomed channel leading southwest (Photo 8). Approximately 50 feet southwest of the piped discharge, the Myricks Fork channel is replaced by non-channelized sheet flow, which enters a small wetland approximately 275 feet southeast of the pipe discharge. This wetland was very saturated with pockets of standing water during the time of the field visit. The small wetland continues in a southwesterly direction until it ceases along the north edge of parcel 28050100400700. It appears that the stream and wetland complex have been filled for quite some time. The fill material has added at least one foot of material at the bottom of the historic Myricks Fork ravine to a point where evidence of stream bed or bank does not exist.

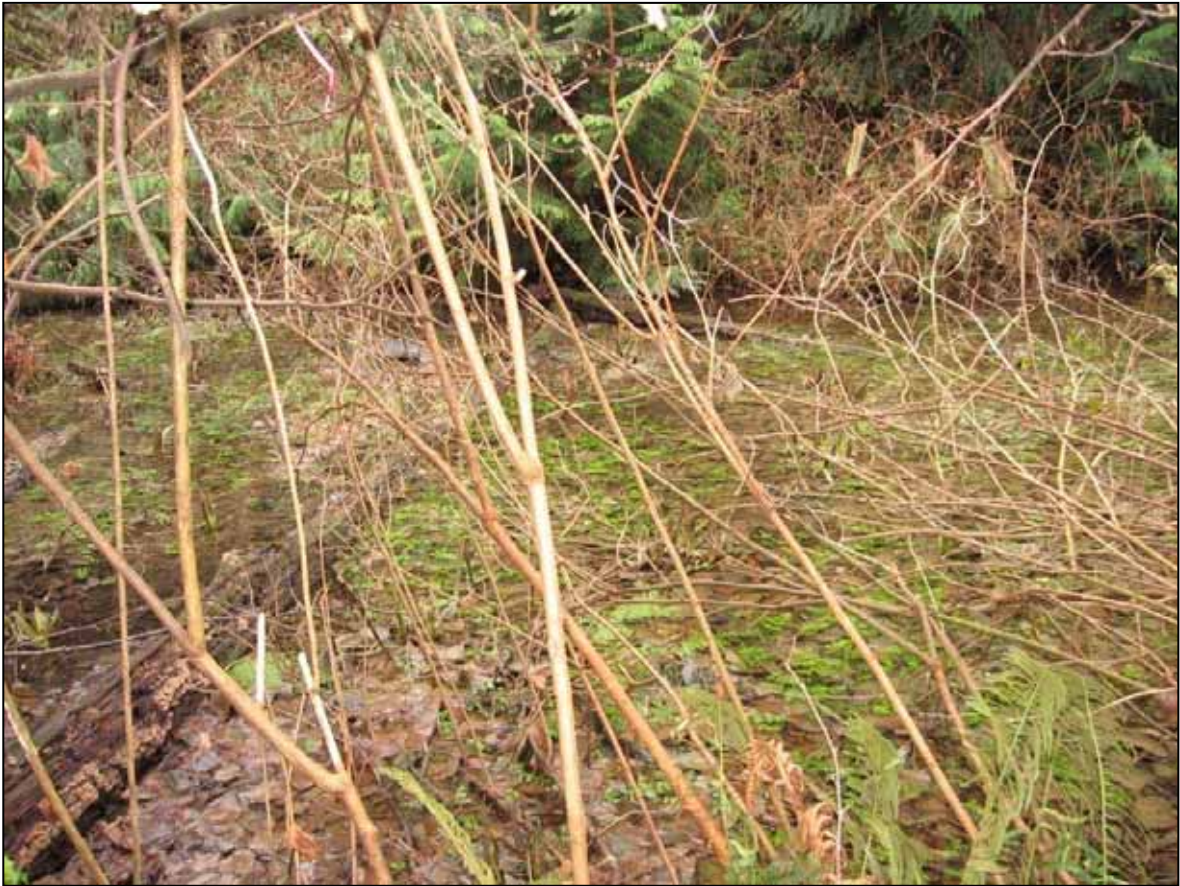
Photo 9. Reach 12. Standing water in a wetland area.

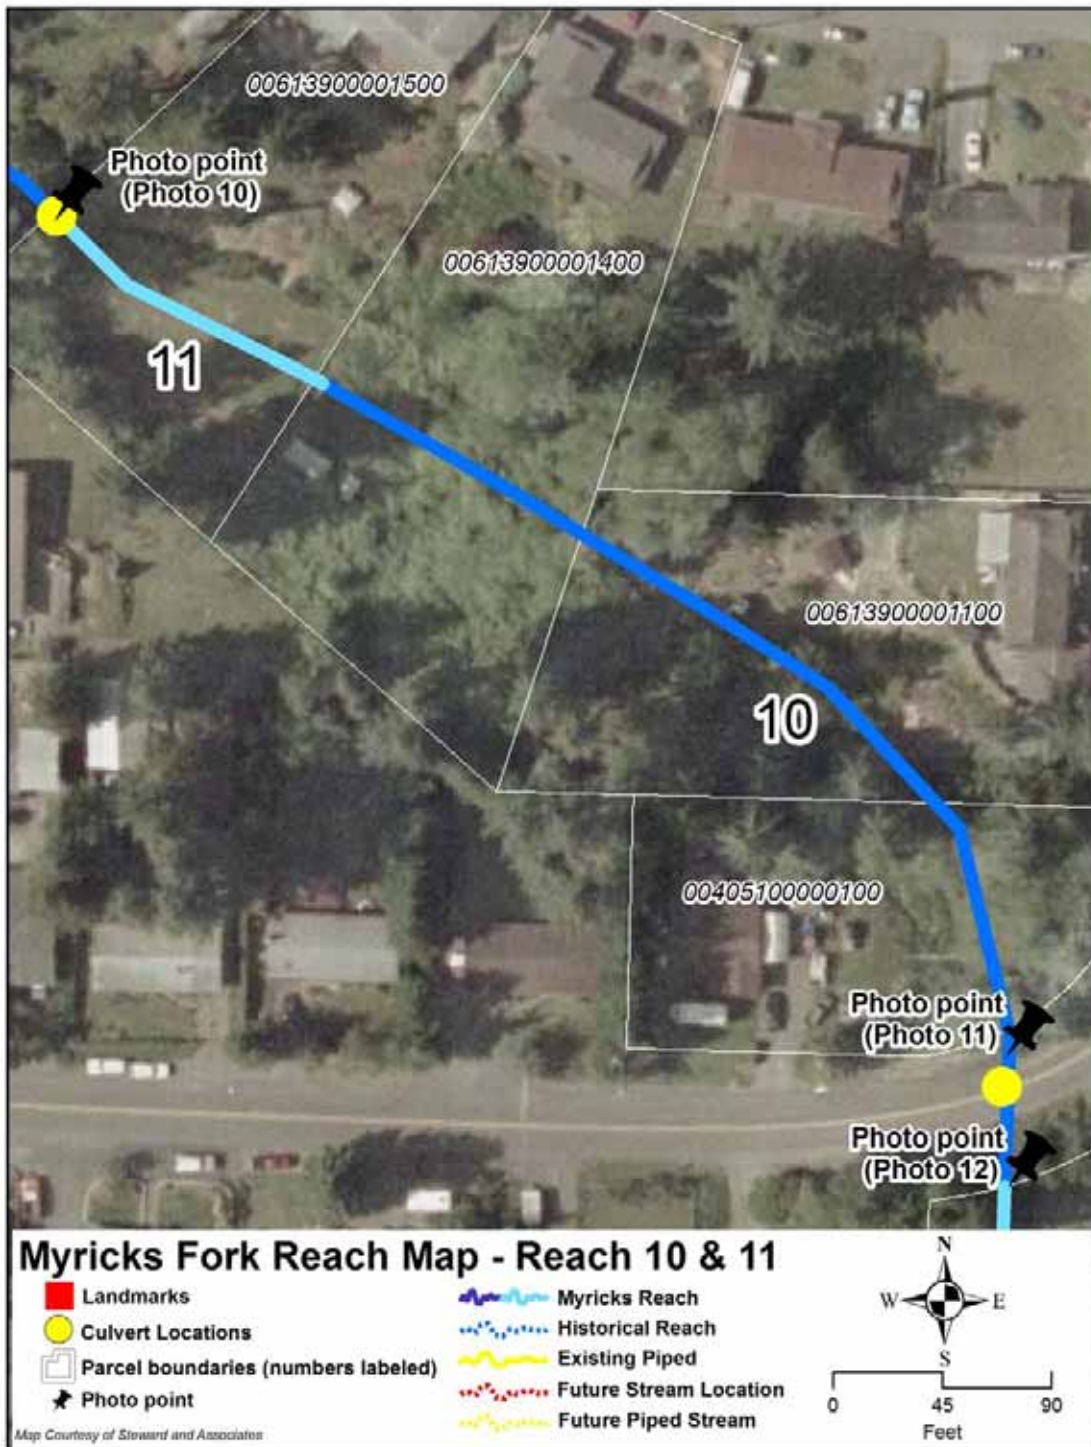
Figure 5. Map of Reaches 10 and 11.

The wetland described in Reach 12 feeds to a 3 ft wide, soft-bottom channel with minimal habitat features (e.g., large woody debris) on parcel 00613900001500 (Figure 5). Residential properties surround Myricks Fork at this point and homeowners have cleared riparian vegetation to the streambank (Photo 10). Mowed lawns dominate the streamside vegetation and limit the ability of the stream channel to maintain cool water temperatures during hot summer months. The stream channel is almost entirely overgrown with emergent grass species, which do help maintain water quality through the reach. Immediately downstream of this ditched reach Myricks Fork becomes associated with another wetland reach, which contains a more diverse array of wetland vegetation species.

To the south of the ditched reach described in Reach 11 above, Myricks Fork flows through three residential properties (parcel numbers 00405100000100, 00613900001100 & 00613900001400), which we did not receive permission to access. We were able to observe Reach 10 from adjacent upstream and downstream reaches and from aerial photographs (Figure 5).

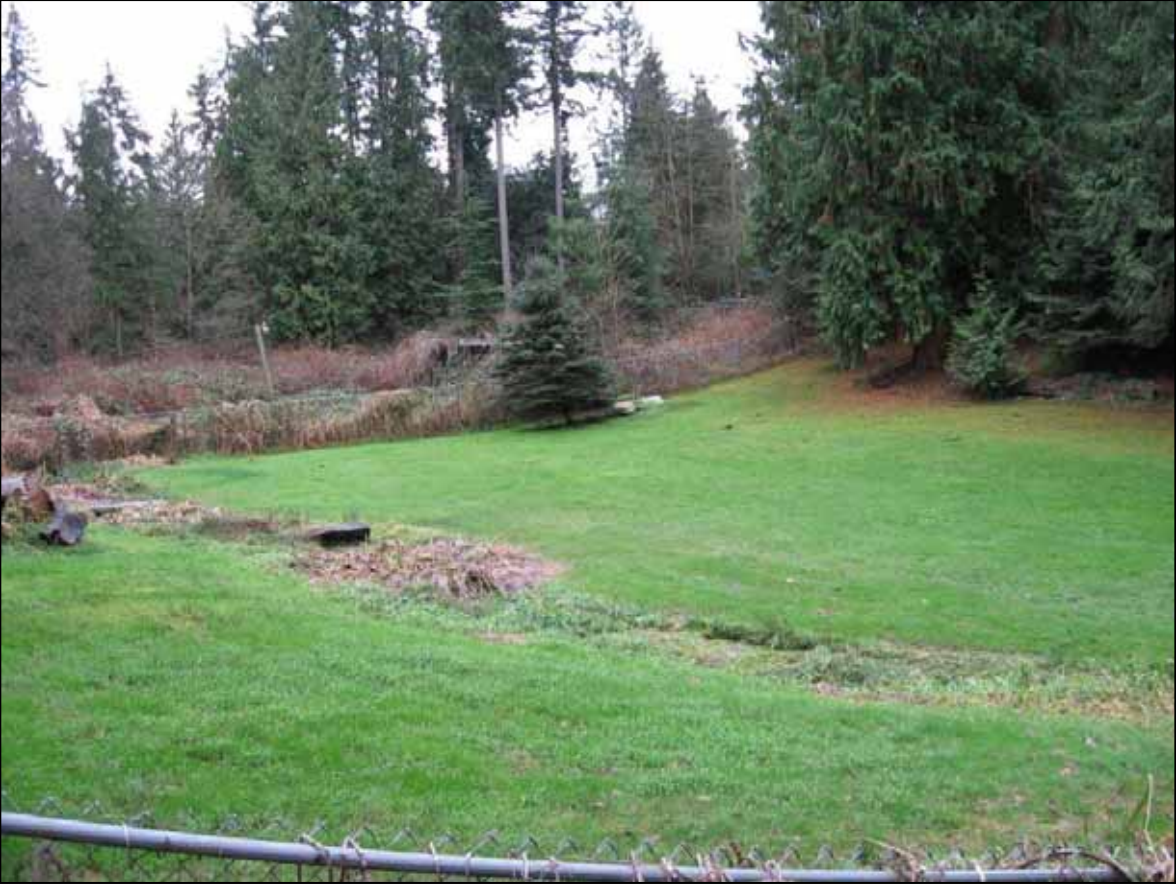
Photo 10. Reach 11. Myricks Fork in channelized ditch on residential property.

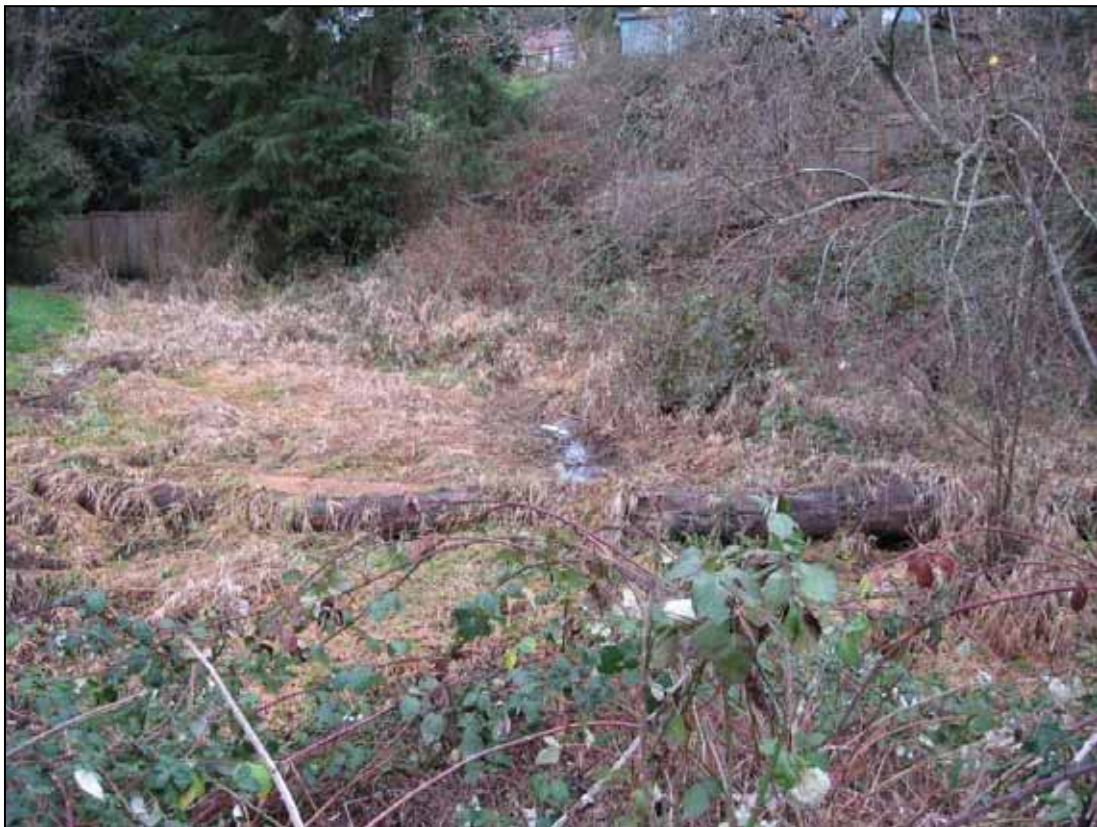
Photo 11. Reach 10. Myricks Fork just north of 62nd Place SE. Fence can be seen in background.

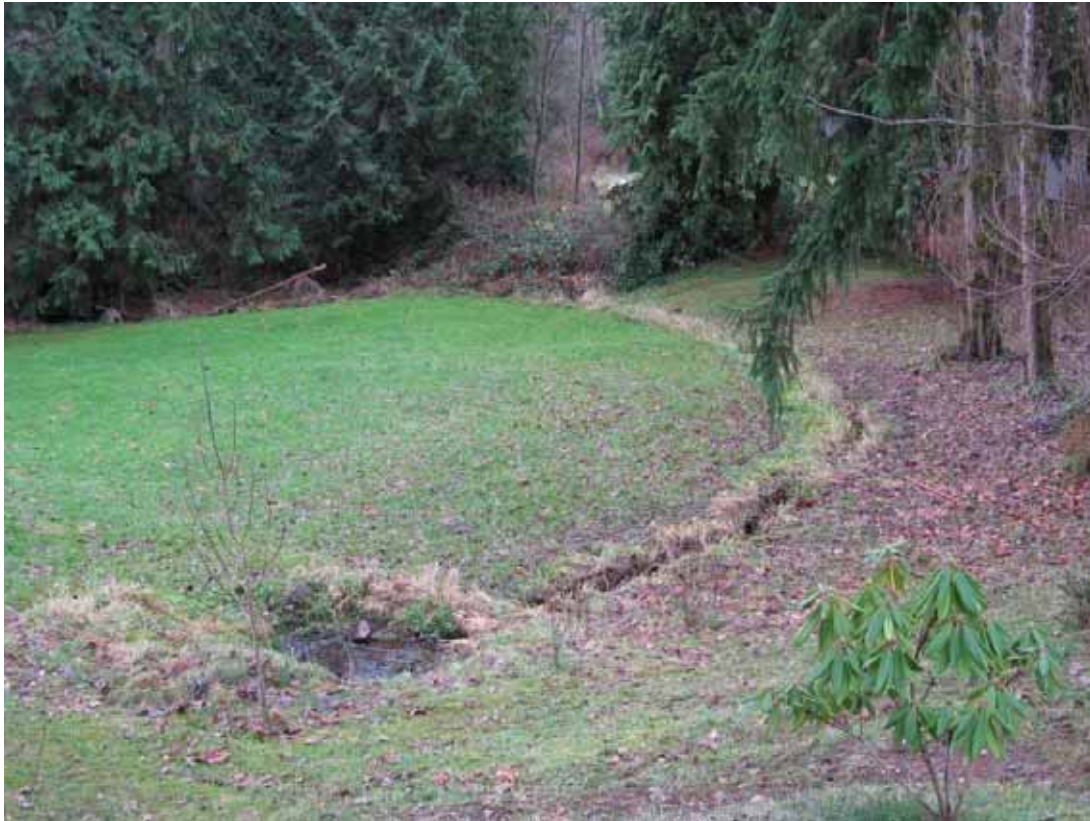
Photo 12. Reach 9. Myricks Fork in a ditch through residential property south of 62nd Street SE.

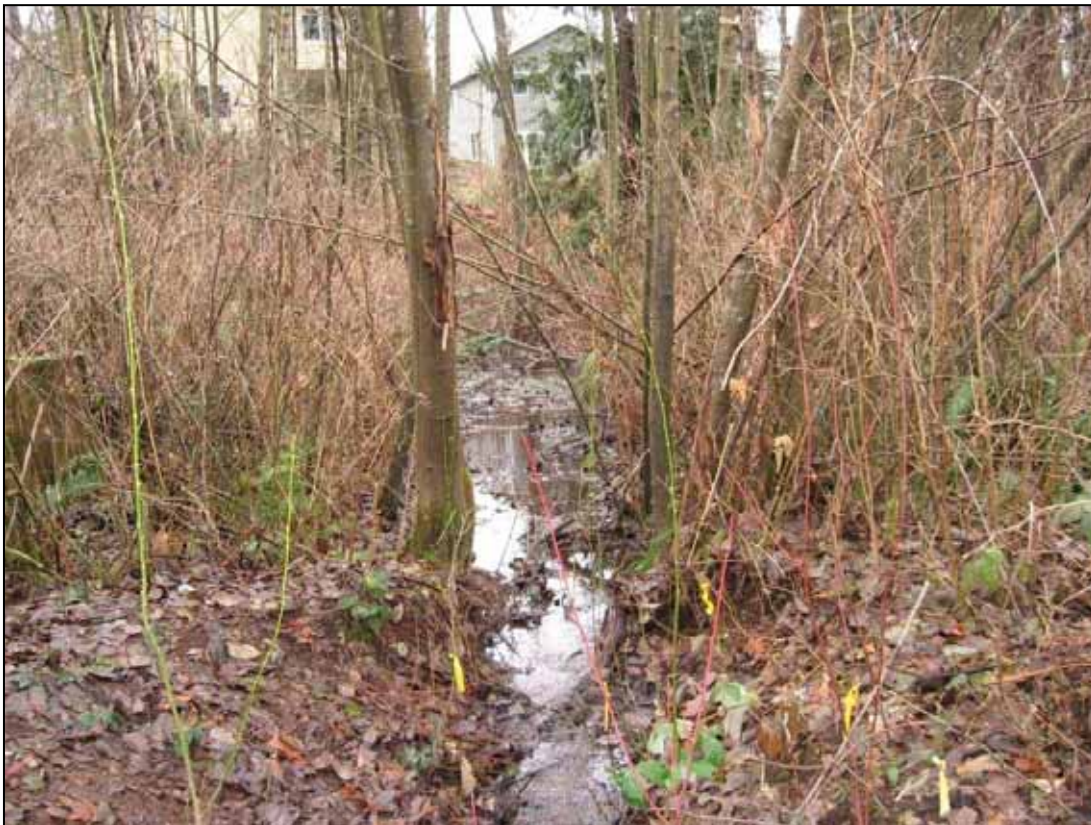
Photo 13. Reach 8. Myricks Fork in Native Protection Growth Easement in Weaver Development.

South of parcel number 00405100003000 and north of parcel number 00538902900002, Myricks Fork enters Reach 8, the Weaver Way Development reach (Figure 6). Reach 8 has been developed as a single family residential community; however, a Native Growth Protection Easement (NGPE) has been established to buffer Myricks Fork from potential adverse impacts (Photo 13).

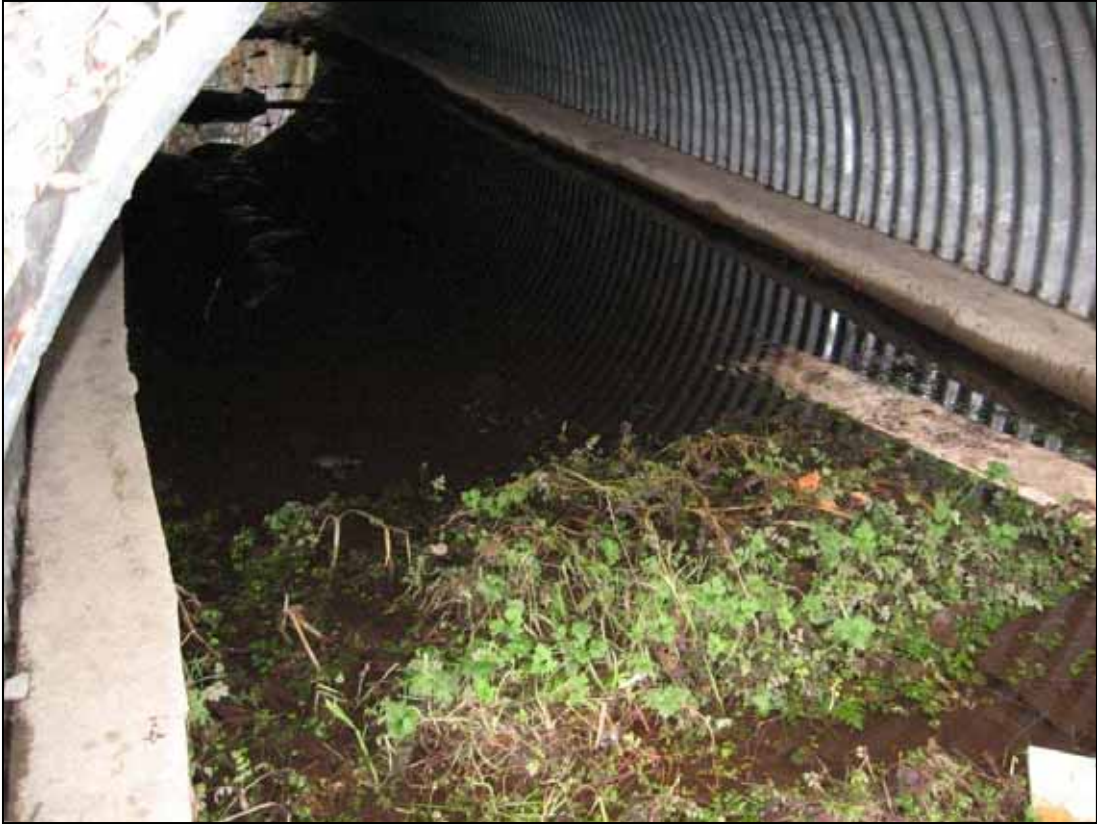
Photo 14. Reach 8. Myricks Fork through 12 ft culvert.

Approximately 200 feet north of parcel number 00538902900002, Myricks Fork flows beneath Weaver Way through a 12 ft arch culvert. The culvert is constructed from corrugated metal and allows Myricks Fork to maintain some semblance of a natural channel (Photo 14). Land cover in the area includes forested canopy immediately to the south in addition to natural vegetation and native plantings in the preserved NGPE. The stream channel and associated wetlands continue south of the arch culvert to Reach 7.

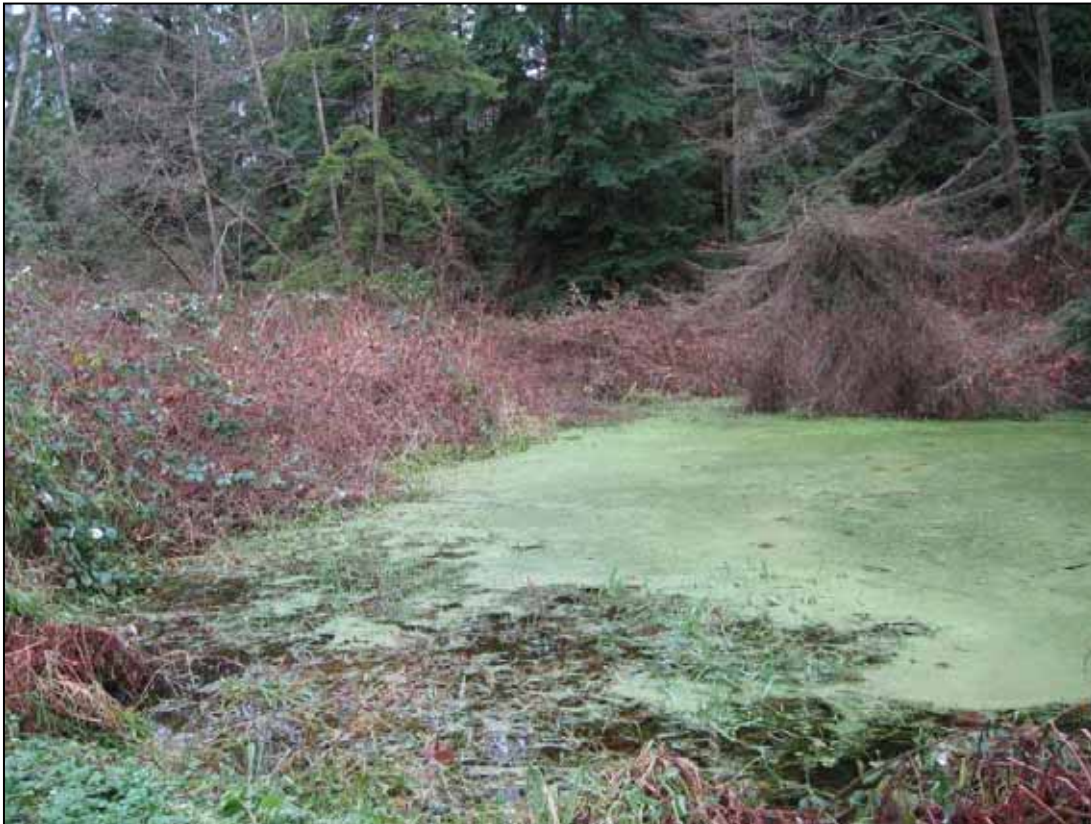
Photo 15. Reach 7. Myricks Fork and associated pond.

Myricks Fork winds through two properties in this reach (parcel numbers 00538902900002 & 00538902800000) (Figure 7). Both properties contain private residences; however the land remains almost entirely forested. From the Weaver Development (Reach 8), Myricks Fork flows south before quickly turning to the east for approximately 500 feet and then making a wide turn back to the south and eventually southeast for approximately 600 additional feet before making its way to 20th Street. Myricks Fork flows through a well defined channel throughout this reach and is again associated with wetlands and ponds for most of its length (Photo 15).
