Myricks Fork Inventory

FINAL Report

Steward and Associates

June 1, 2007

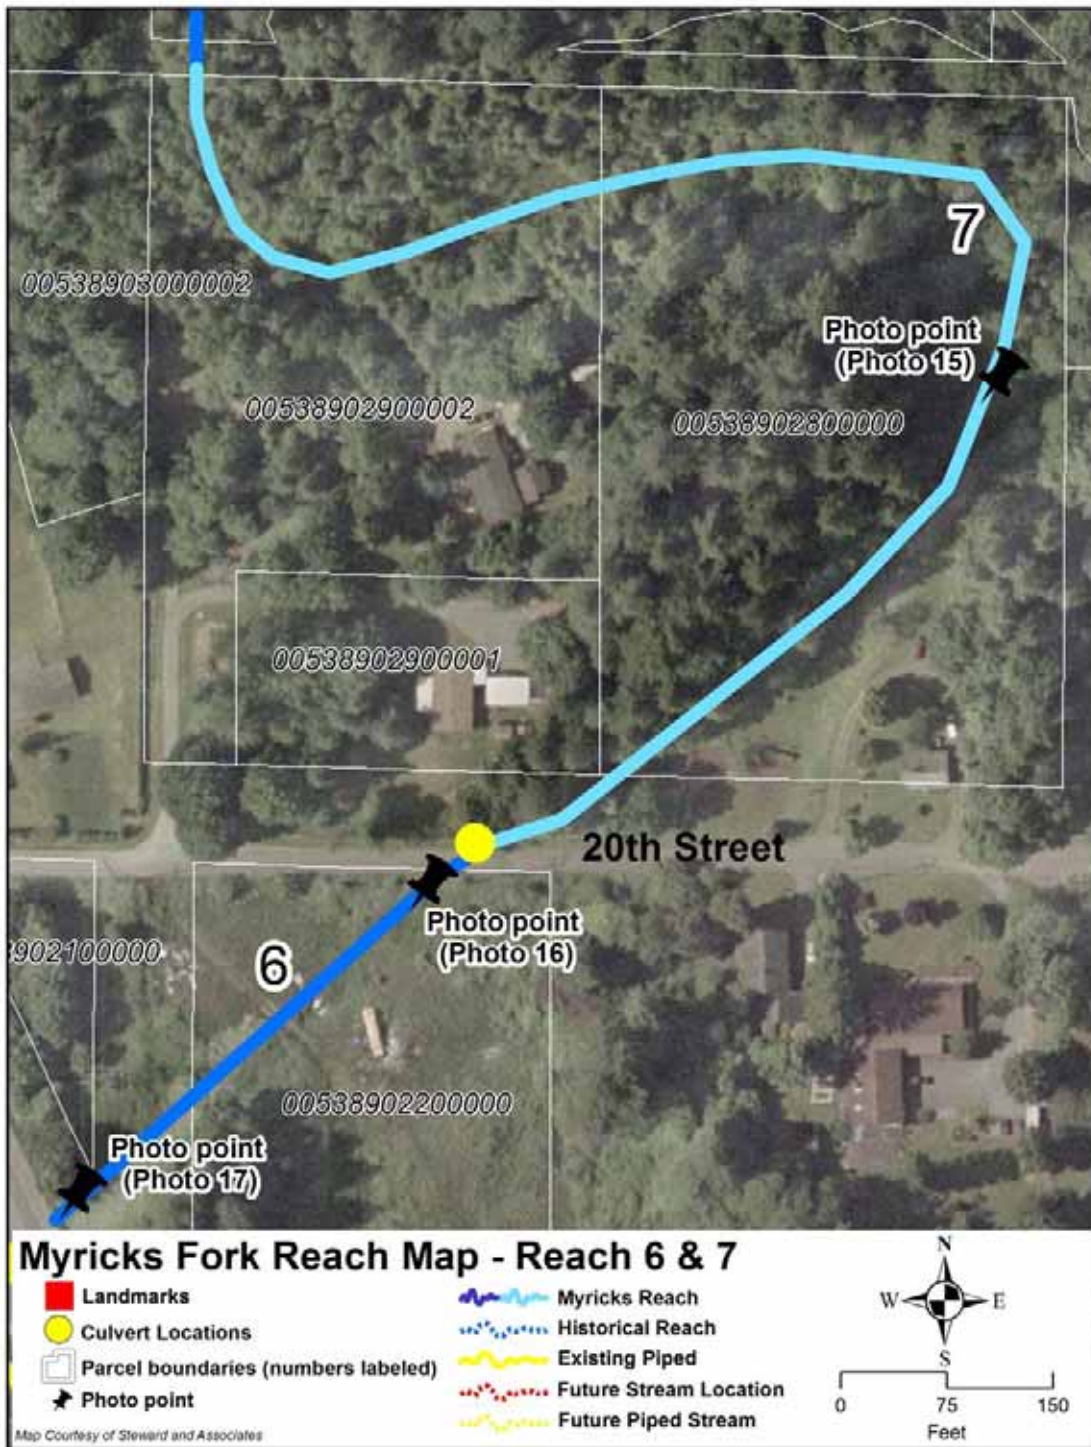
Figure 7. Map of Reaches 6 and 7.

Myricks Fork winds through two properties in this reach (parcel numbers 00538902900002 & 00538902800000) (Figure 7). Both properties contain private residences; however the land remains almost entirely forested. From the Weaver Development (Reach 8), Myricks Fork flows south before quickly turning to the east for approximately 500 feet and then making a wide turn back to the south and eventually southeast for approximately 600 additional feet before making its way to 20th Street. Myricks Fork flows through a well defined channel throughout this reach and is again associated with wetlands and ponds for most of its length (Photo 15).

Myricks Fork crosses beneath 20th Street in a 24 inch circular concrete culvert, emerging briefly north of parcel 00538902200000 (Figure 7). Myricks Fork then sheet flows over sand and small gravel substrate and through an overgrown field of Himalayan blackberry, where a distinct channel was absent. Myricks Fork flow presumably infiltrates at some point for a short distance as it traverses the blackberry thicket on parcels 00538902100000 and 00538902200000 (Photo 16). We come to this conclusion from the fact that water once again emerges into the ditch on the east side of Bickford Avenue (see Photo 17 in the Reach 5 description) near a blue sign bearing the creek's name.

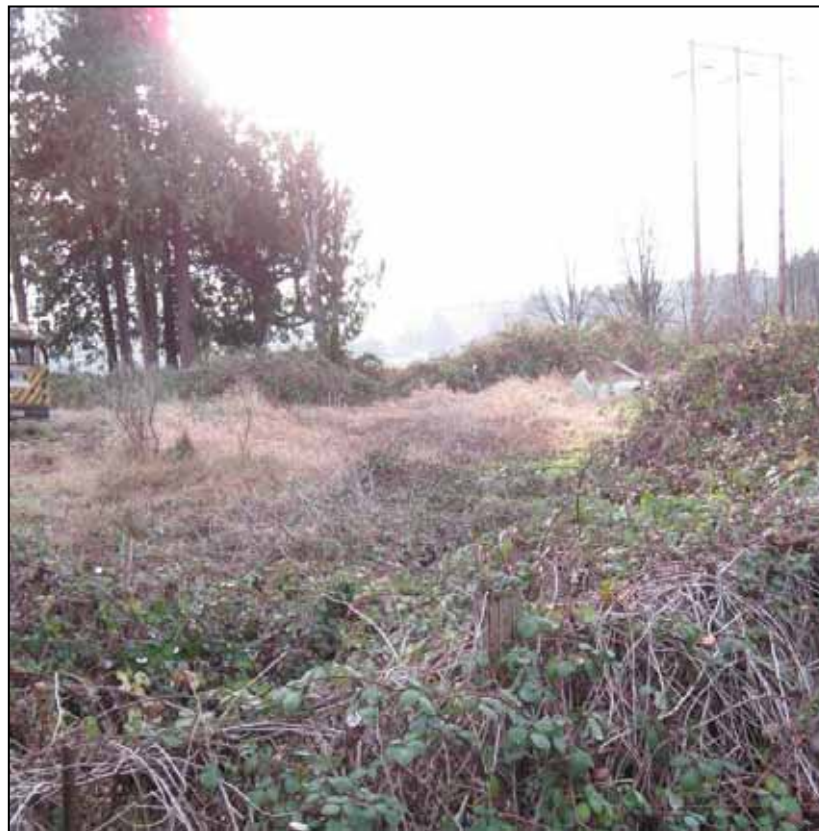
Photo 16. Reach 6. Properties traversed by Myricks Fork, south of 20th Street. Presumably, Myricks Fork flows subterranean through at least part of these properties.

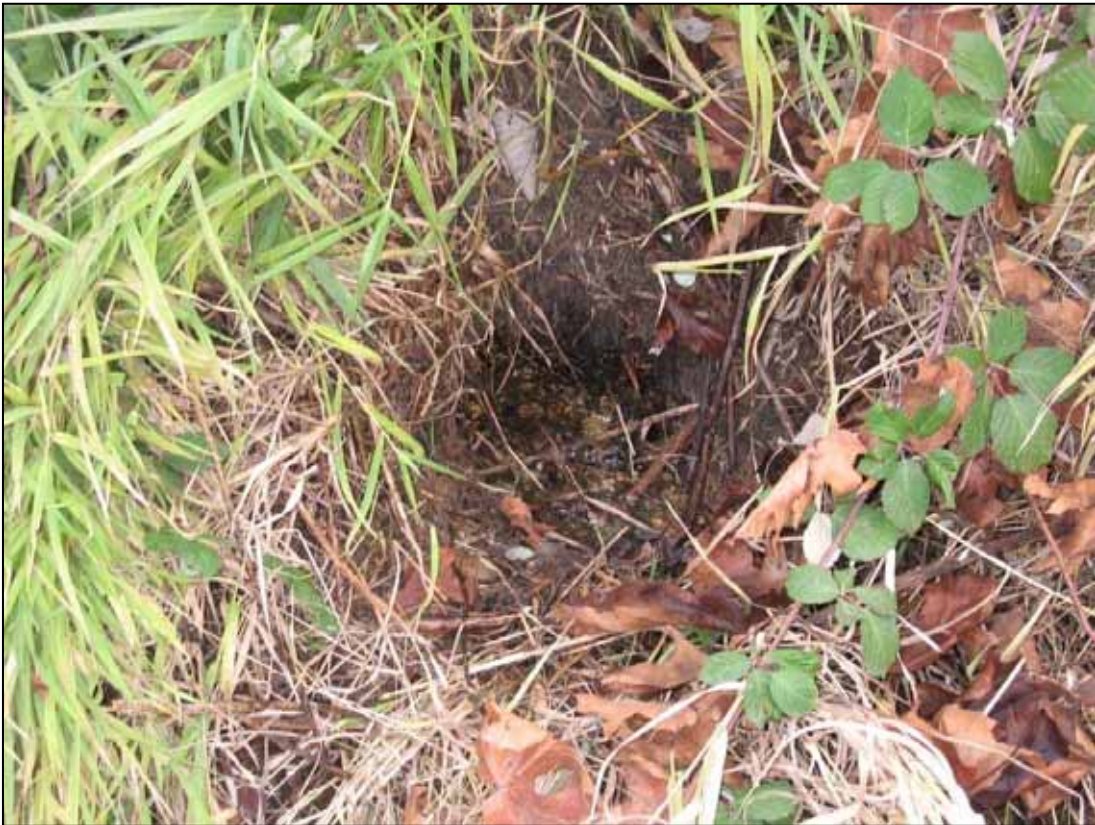
Photo 17. Reach 5. Myricks Fork emerging from embankment on east side of Bickford Avenue.

Myricks Fork appears to emerge from the Himalayan blackberry covered embankment facing the east side of Bickford Avenue, south of 20th Street (Figure 8). After Myricks Fork emerges into the Bickford Avenue ditch, it flows south for approximately 20 feet before entering a 12 inch circular concrete culvert that conveys flow west beneath Bickford Avenue.

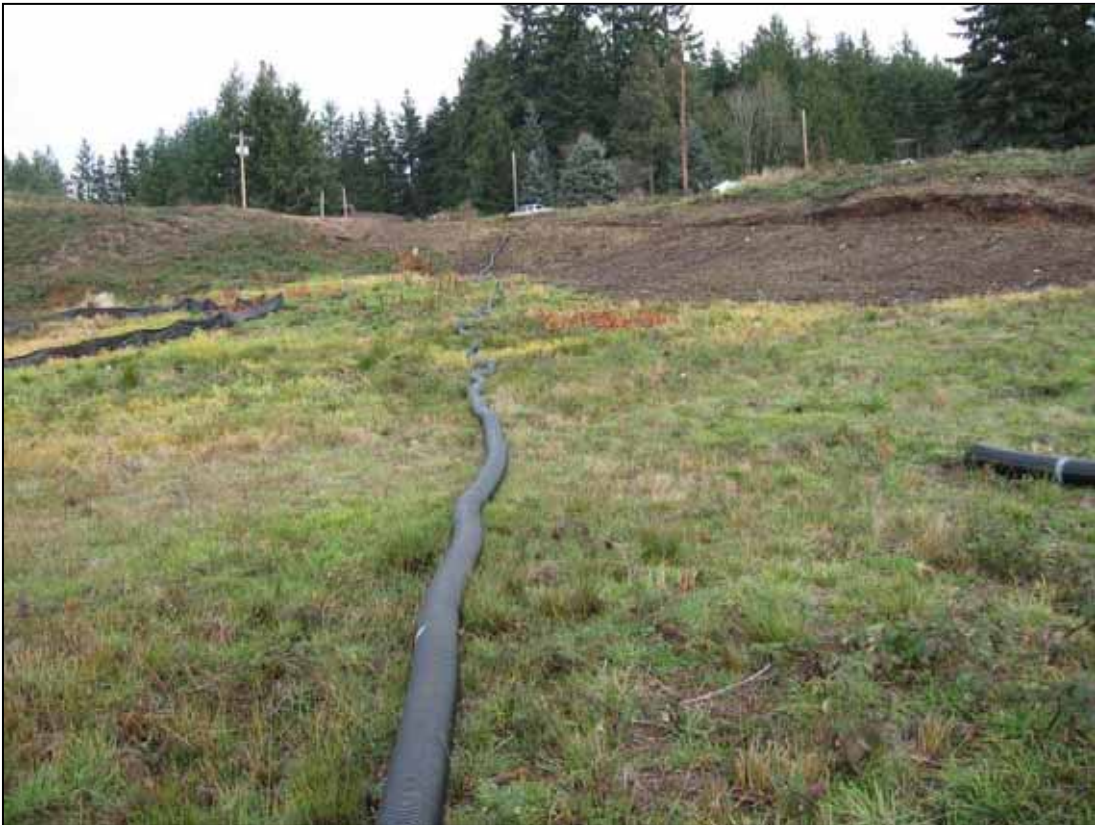
Photo 18. Reach 4. Myricks Fork in 6 inch pipe.

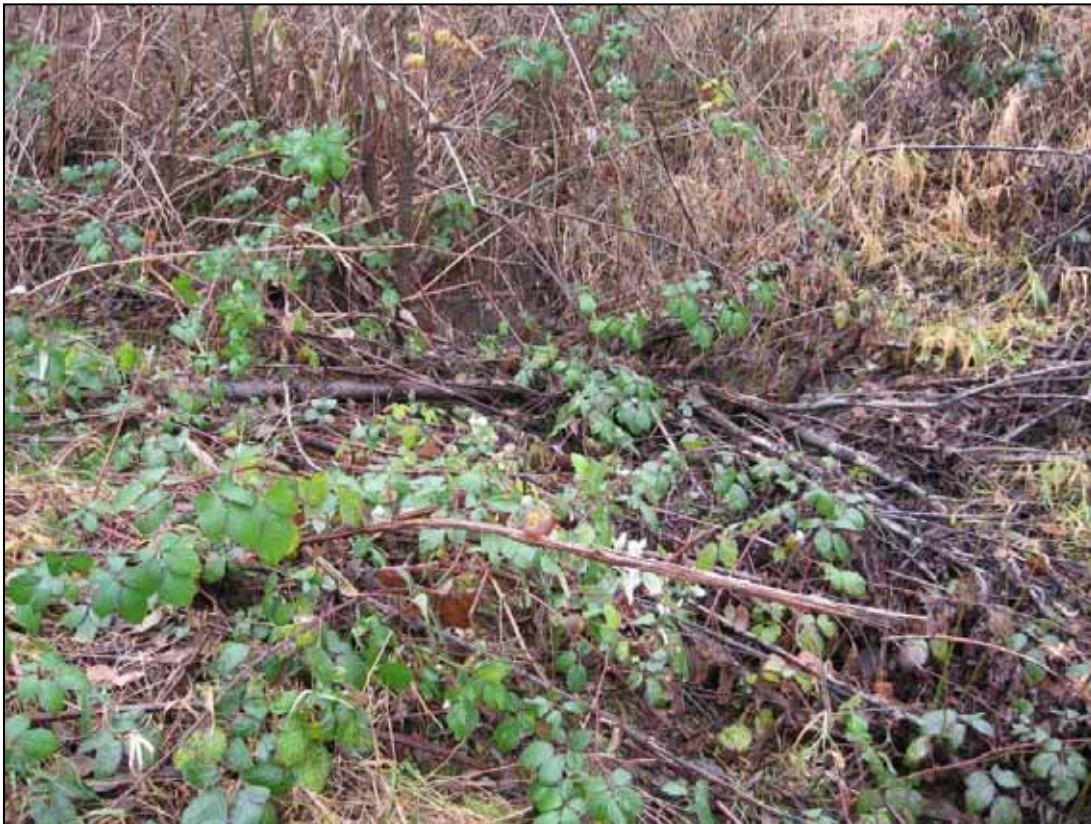
Photo 19. Reach 3. Myricks Fork near Highway 9 right-of-way.

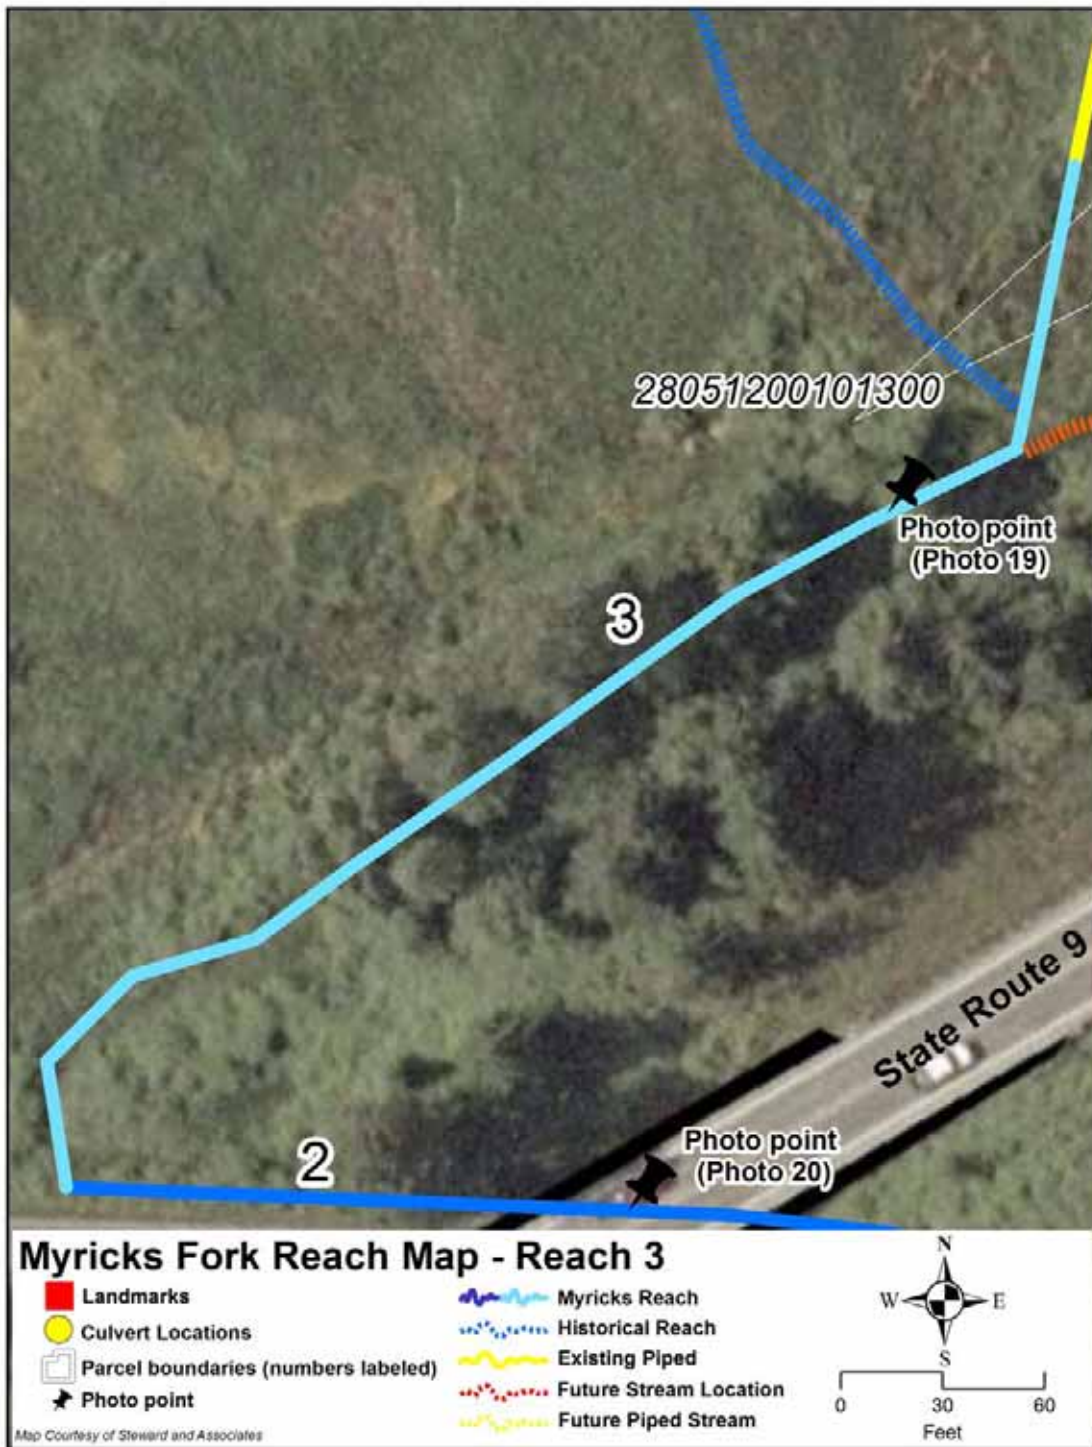
Figure 9. Map of Reach 3.

Myricks Fork currently exits Reach 4 through the 6 inch corrugated black pipe described in the Reach 4 section above and enters the SR9 right-of-way, where it turns and flows to the southwest parallel to the highway. Reach 3 continues to flow along the northwest side SR9 for approximately 500 feet before spilling into the ditch along the north side of 16th Street (see Reach 2). Reach 3 contains some wetland vegetation but is dominated by growths of Himalayan blackberry and reed canary grass (Photo 19). In Reach 3, Myricks Fork flows through a low-gradient open channel and associated overbank wetland areas. Reach 3 channel substrate is dominated by sand and small gravel, with pockets of silt and clay. Once development of the Bickford Business Park is complete, Myricks Fork will be taken from its temporary bypass pipe and placed into the constructed Reach 4 channel. As described above, Myricks Fork will discharge from the constructed Reach 4 channel to the SR 9 right-of-way about 500 ft northeast of its current discharge location (Figure 9).

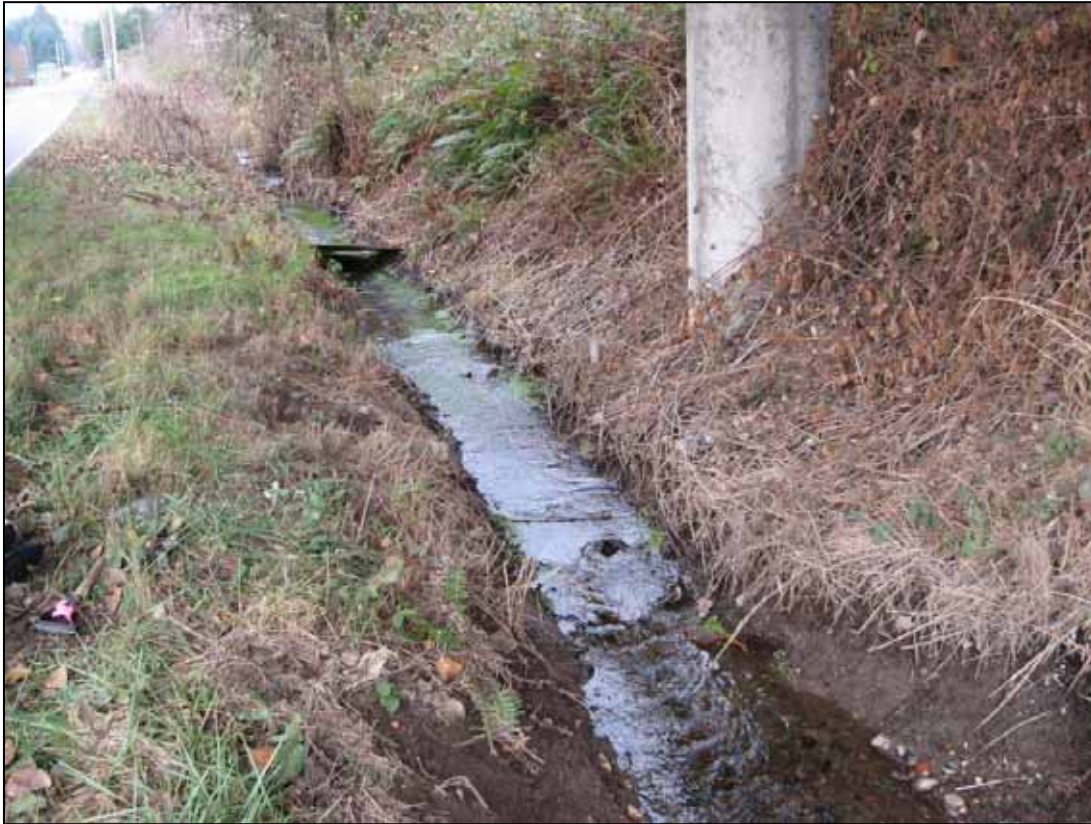
Photo 20. Reach 2. Myricks Fork along 16th Street.

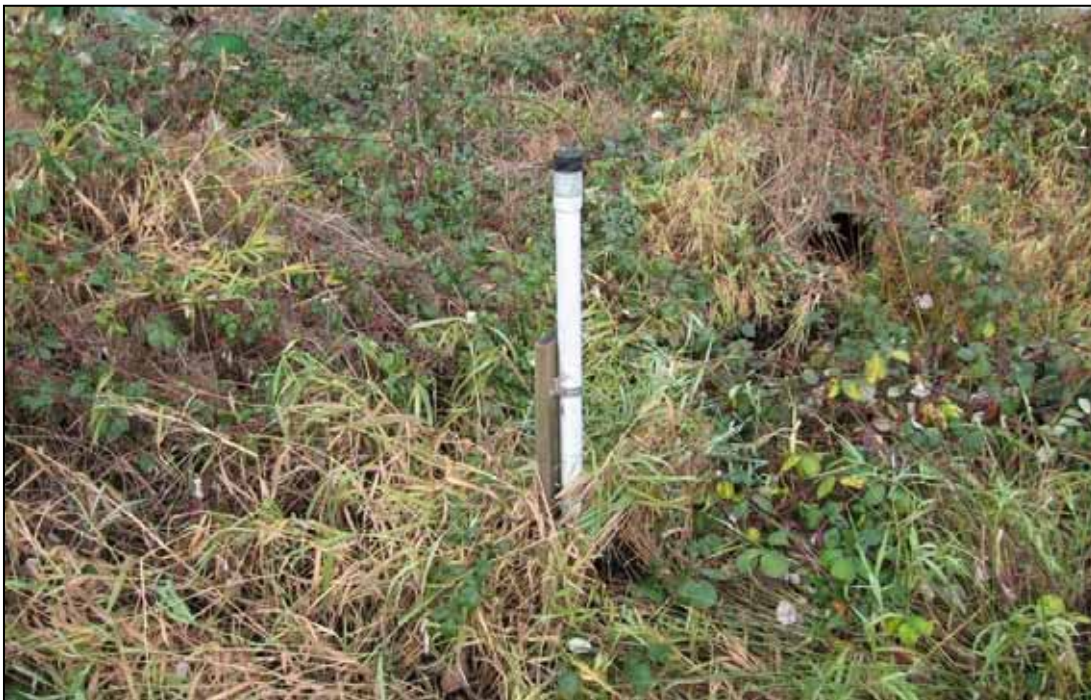
Photo 21. Reach 1. Myricks Fork flowing through 25 ft daylighted section between 16th Street and commercial property driveway culverts. Culvert heading under 16th Street can be seen near top right.
